**RE: Amendment of the Water Quality Management Plan for Dane County to  
revise Environmental Corridor Boundaries near the new Waunakee Public  
Library**

# WAUNAKEE LIBRARY

# STORMWATER MANAGEMENT REPORT

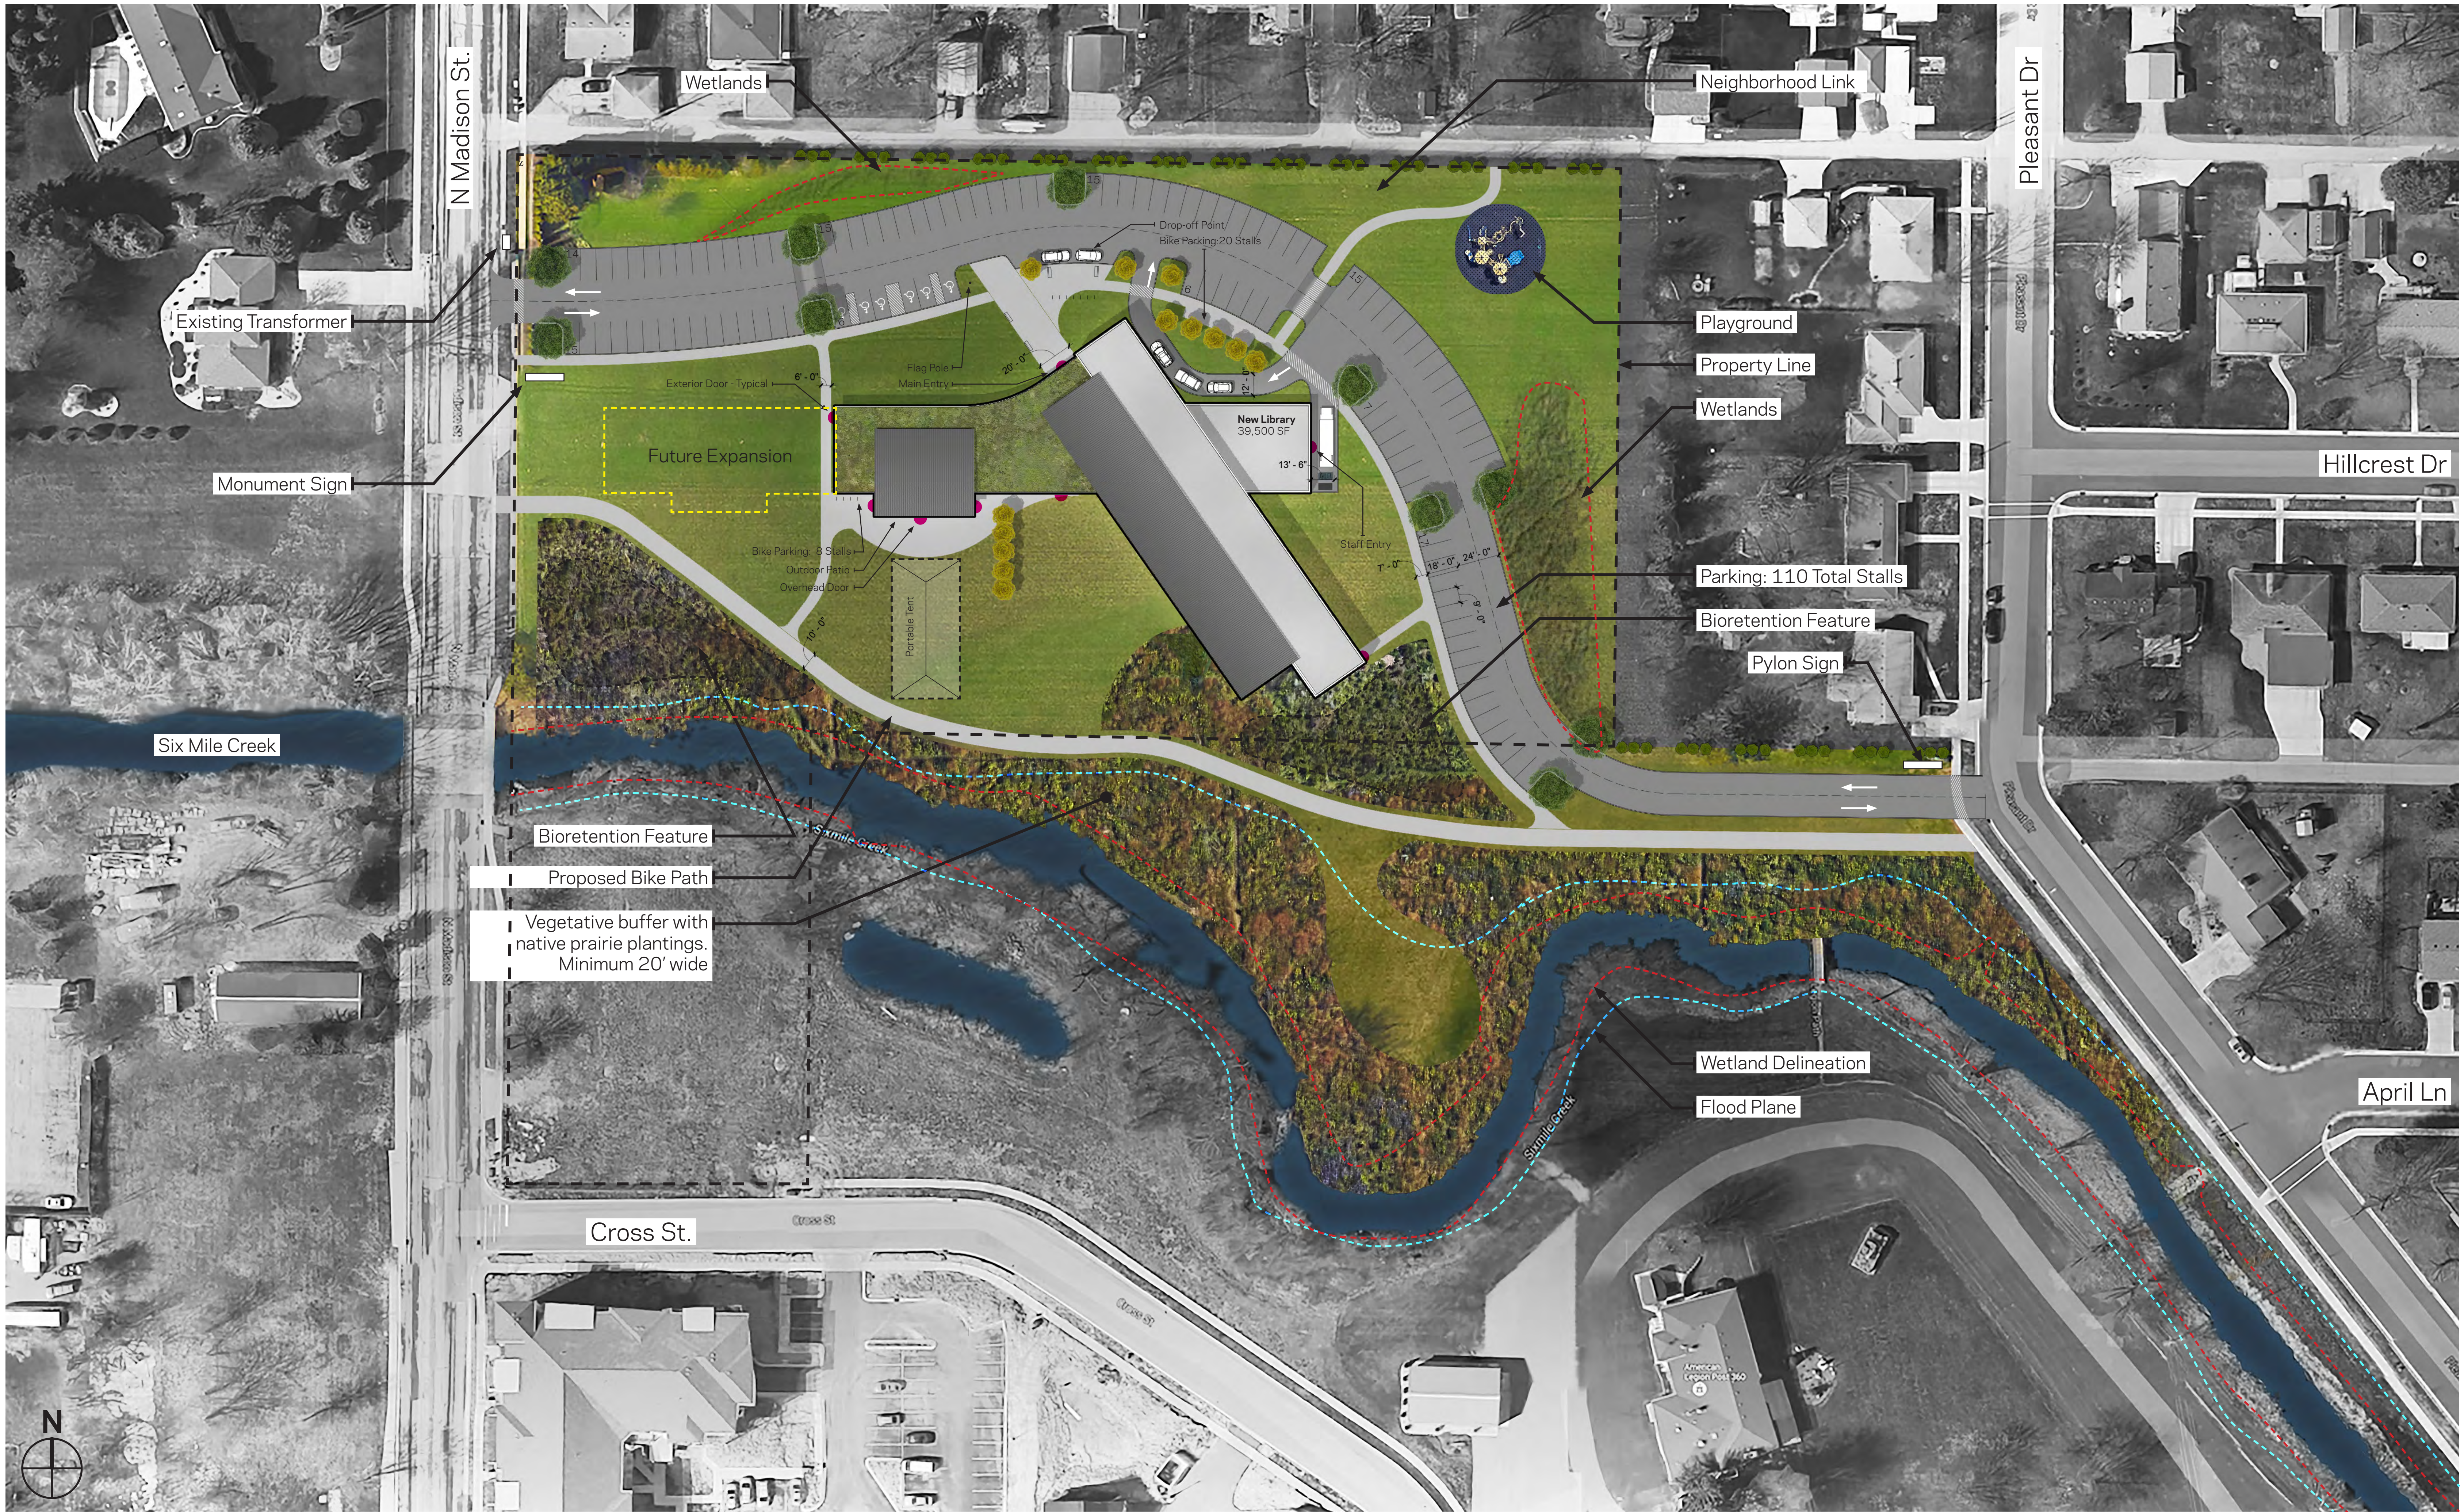
#16 – Another picture showing some junk within Six Mile Creek corridor.

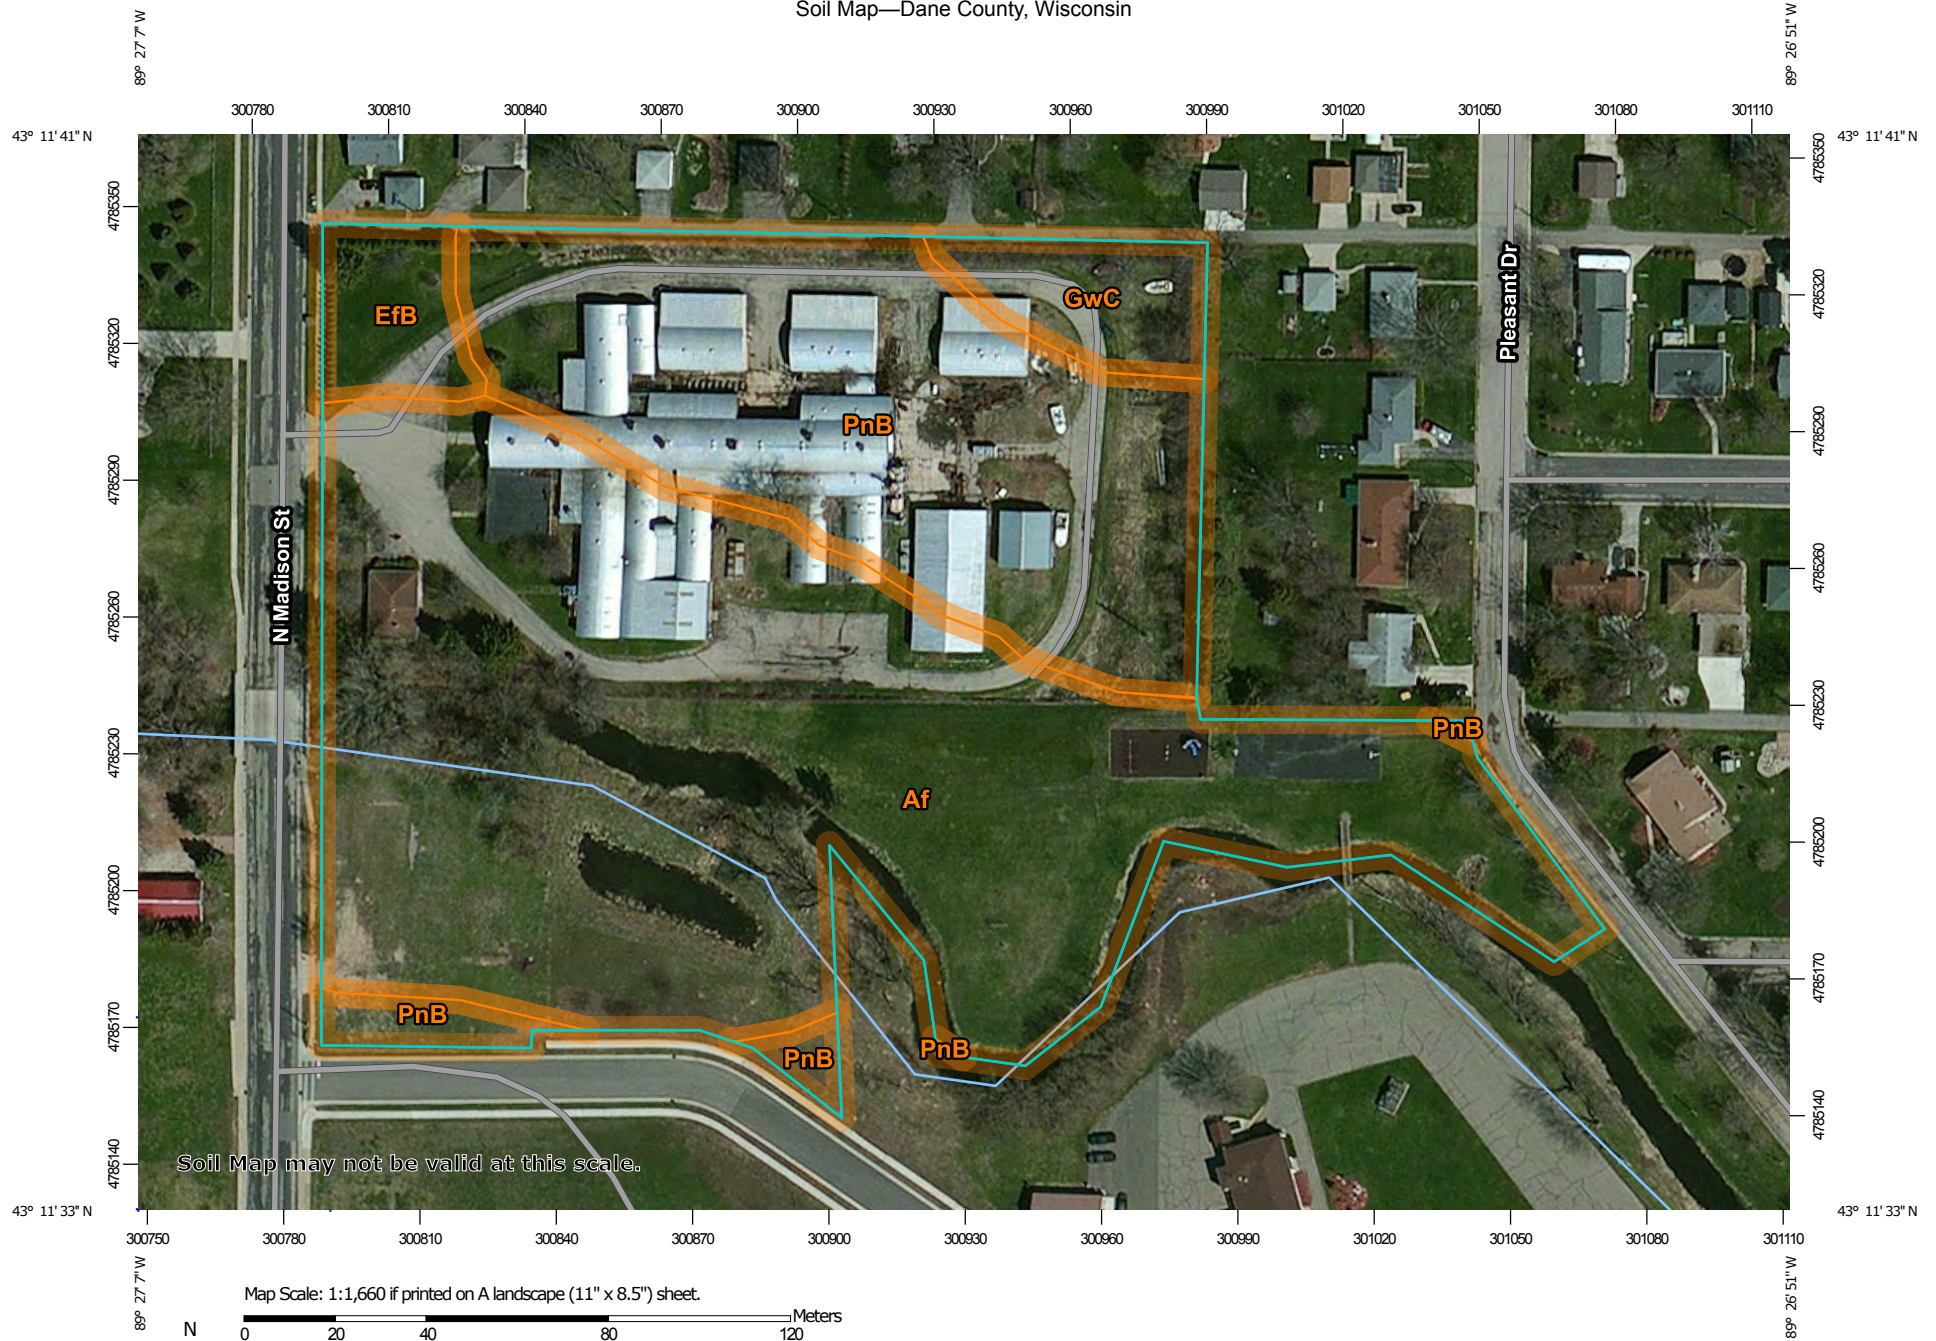
# Soil Map—Dane County, Wisconsin

Soil Map may not be valid at this scale.

Map Scale: 1:1,660 if printed on A landscape (11" x 8.5") sheet.
