Wetland Delineation Report

Woodland Drive West

**Village of Waunakee, Dane County
Wisconsin**

August 9th, 2022

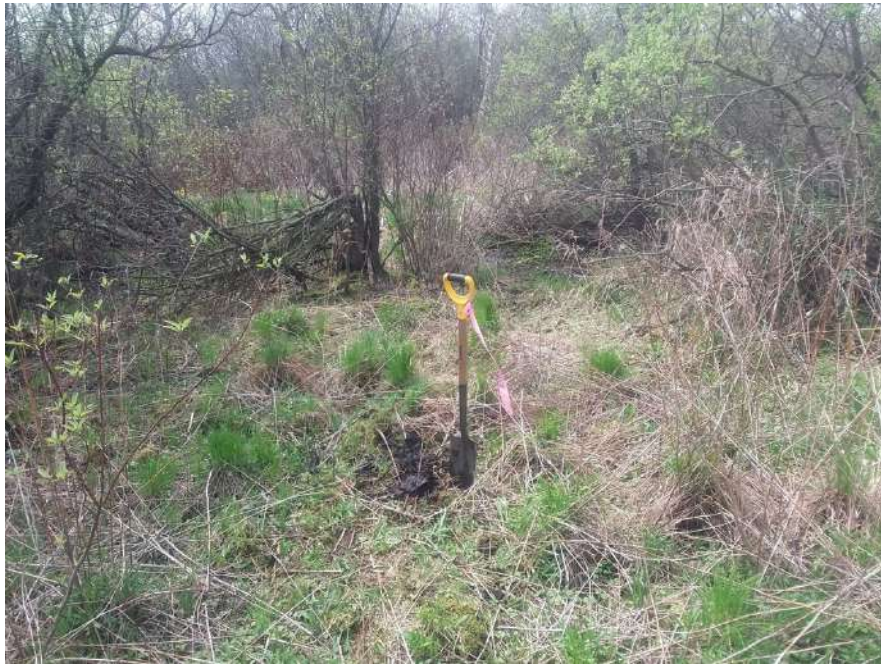
Wetland - Plot 1

Surface water was observed in 1 of 4 wetland sample plots (plot 3). Soil saturation within 12 inches of the ground surface was observed in 3 of 4 wetland sample plots (1, 5 & 7). Plot 7 also showed a water table within 12 inches of the surface.

Soils	
Hydric indicators	Redox Dark Surface-F6 (plot 5). Plot 3 possessed standing water, so soil was assumed hydric, see notes below.
Hydric Indicators Missing?	Plots 1 & 7. Investigator used professional judgment, see notes below.
Surface Horizon Colors & Textures	10 YR 2/1, silt loam
Subsoil Horizon Colors & Textures	Investigator did not observe subsoils at the depths examined (24 inches).

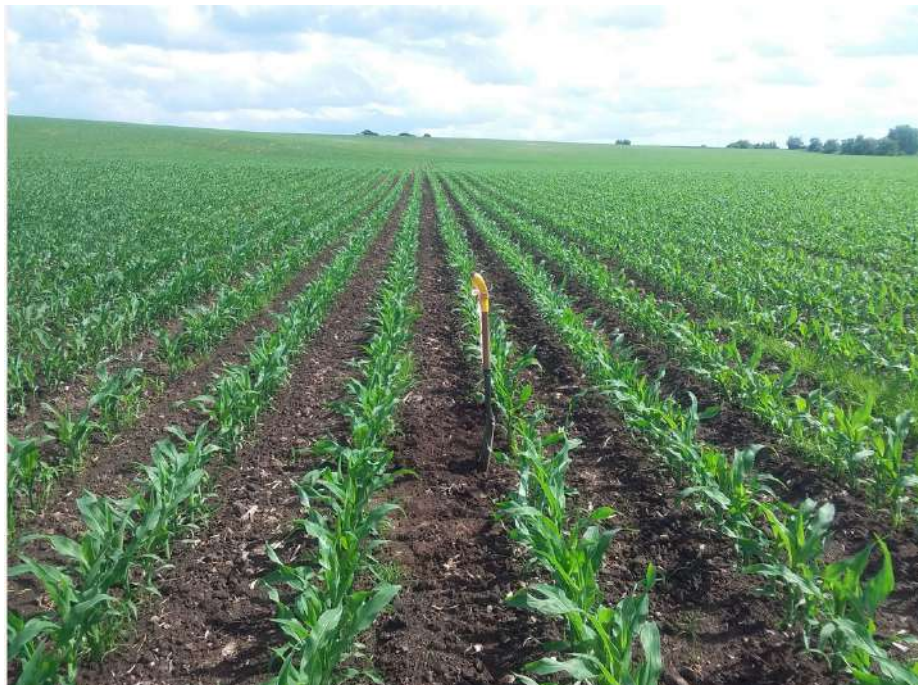
Upland - Plot 11

Hydrology	
Primary Hydrology Indicators?	None
Secondary Hydrology Indicators?	None
Signatures on Aerial Imagery?	Wetland signatures were observed in area of plots 11 & 12. See “ <i>Discussion of Low-lying Field</i> ” below & Appendixes I & II.
