City of Stoughton 2023 URBAN SERVICE AREA AMENDMENT

USH 51 AND CTH B DEVELOPMENTS

June 12, 2023

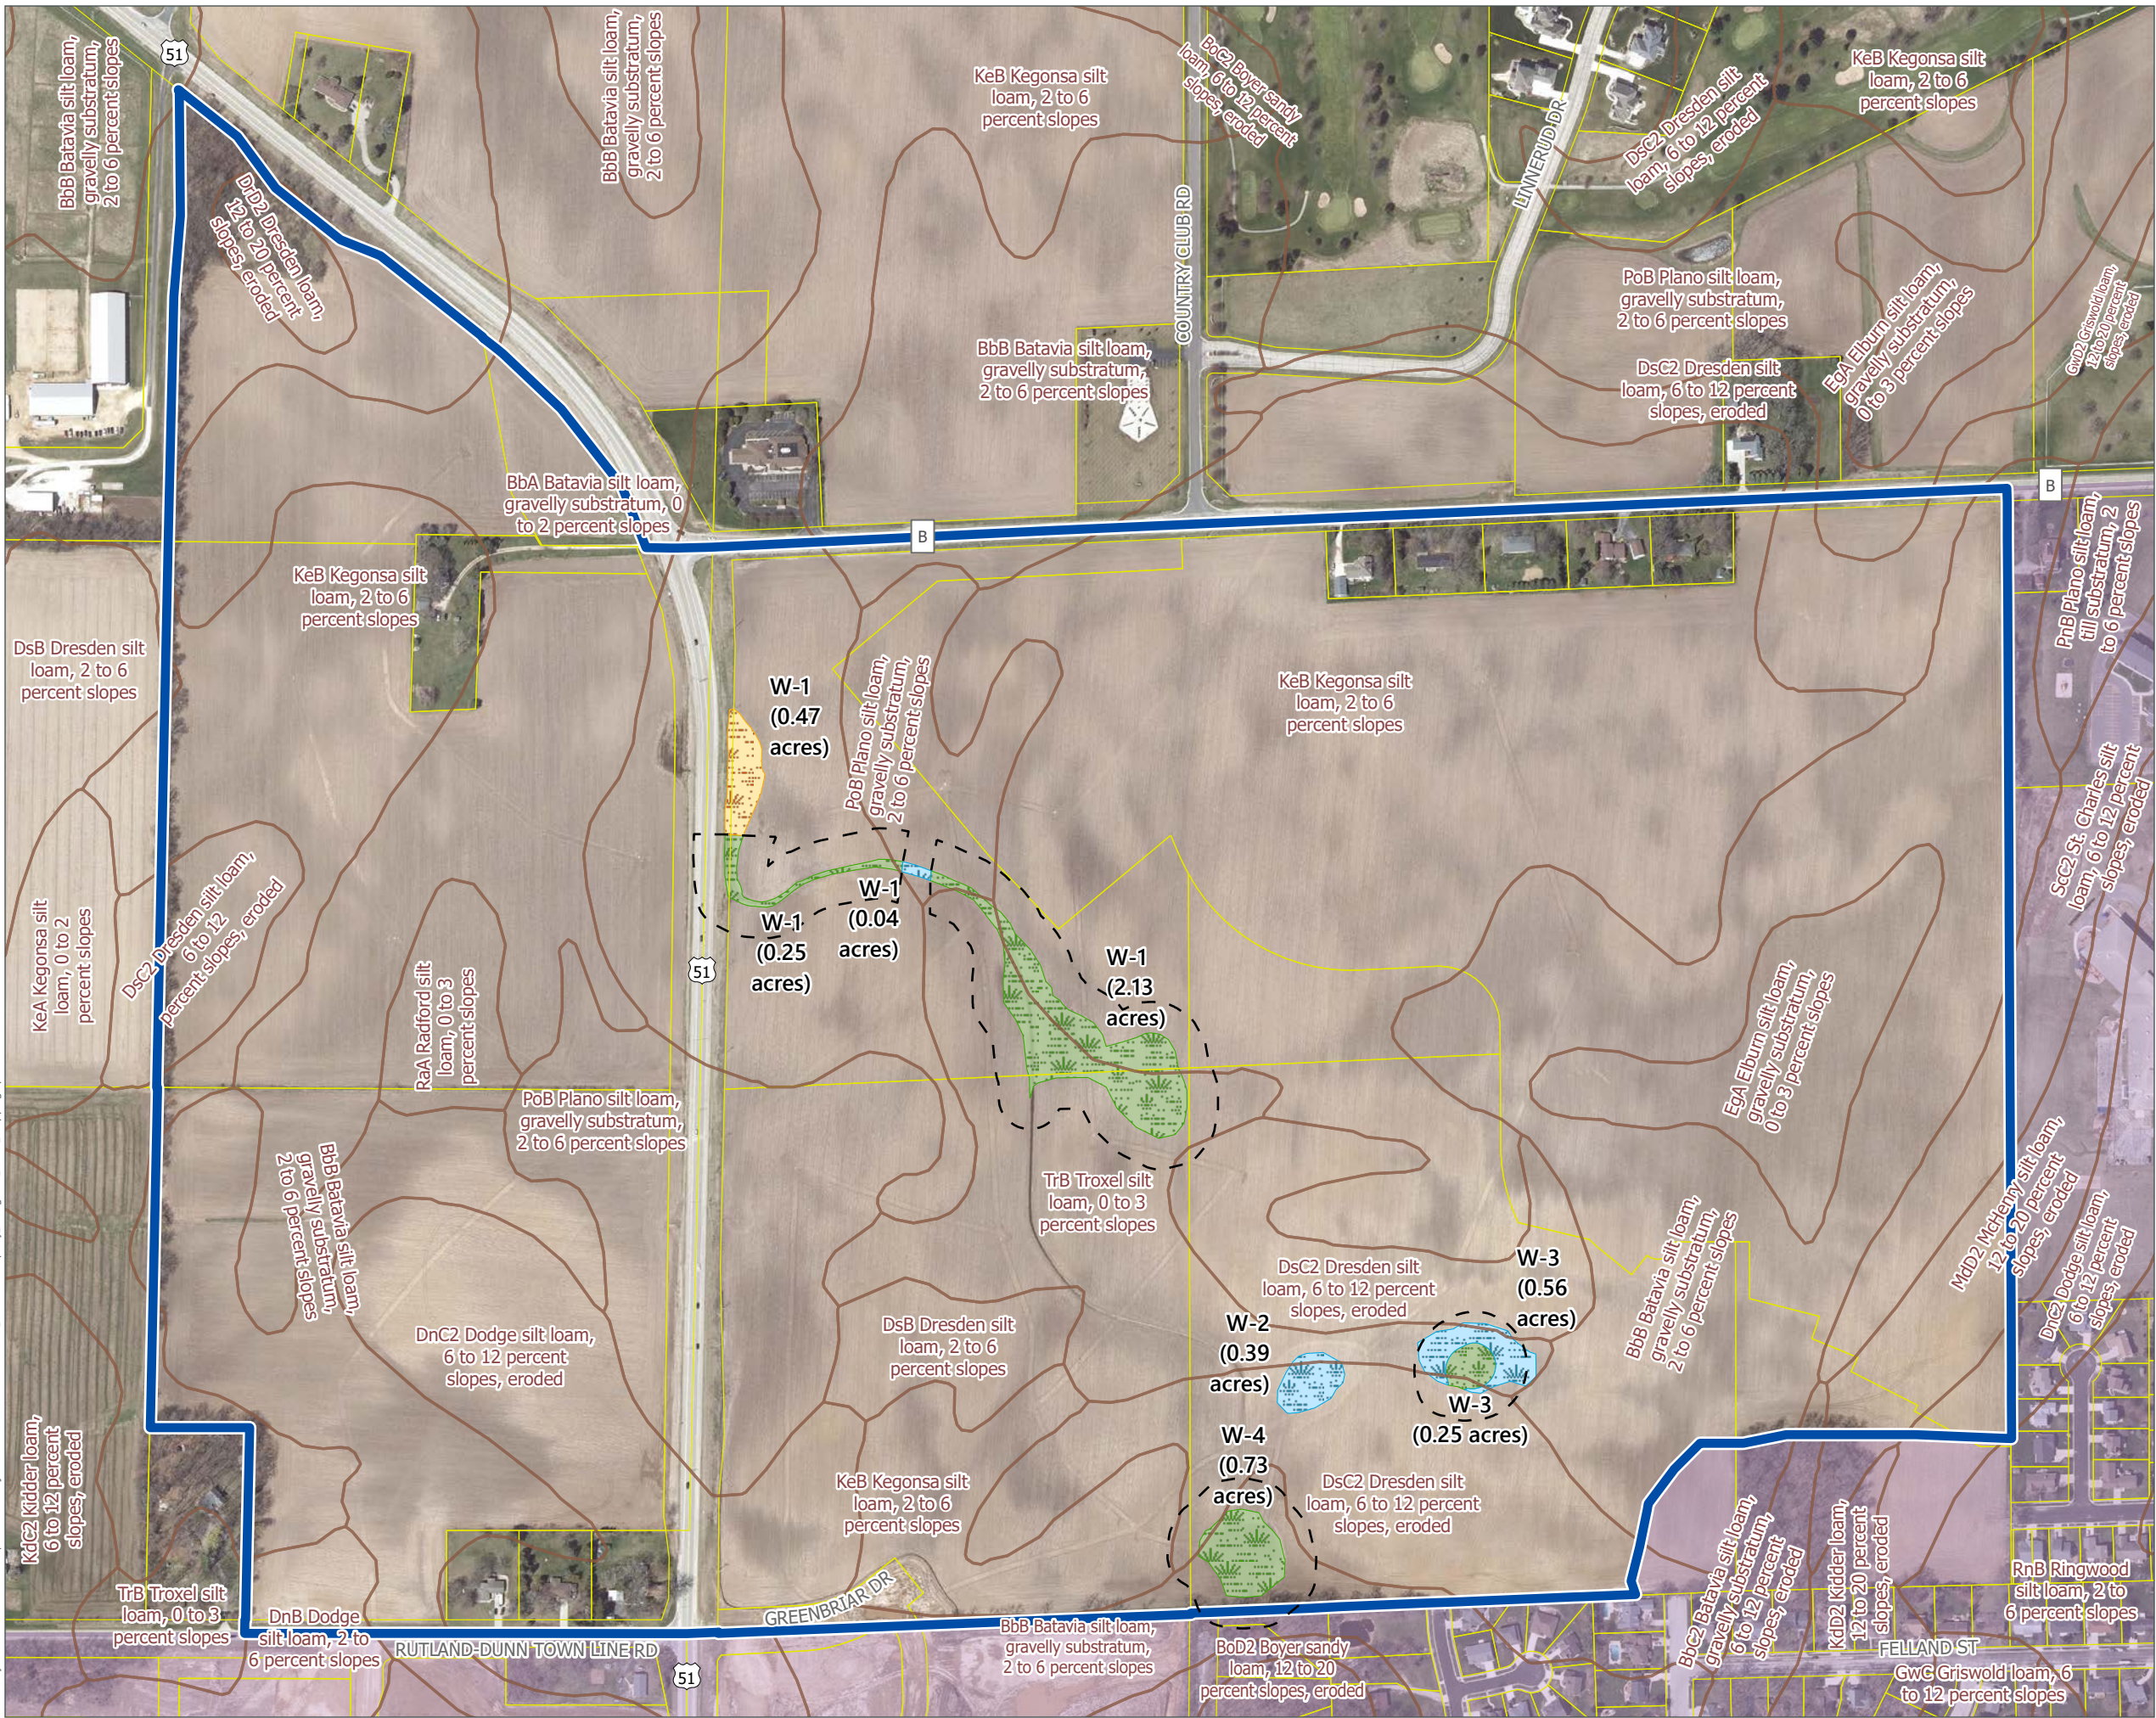
Map 4.1A Wetland Data

- Existing Wetland Status**
- Anticipated Disturbance and Removal by DOT
 - Permitted Disturbance/Fill
 - To Remain

Data Sources:
Dane County GIS (2023)
Aerial: Dane County (2022)
Wetlands Delineated by TRC (2022)

Based on the wetland delineation completed by TRC, four wetlands (W-1, W-2, W-3 and W-4) were delineated totaling 4.82 acres of wetlands within the 181-acre Study Area. No other aquatic resources were observed within the Study Area.

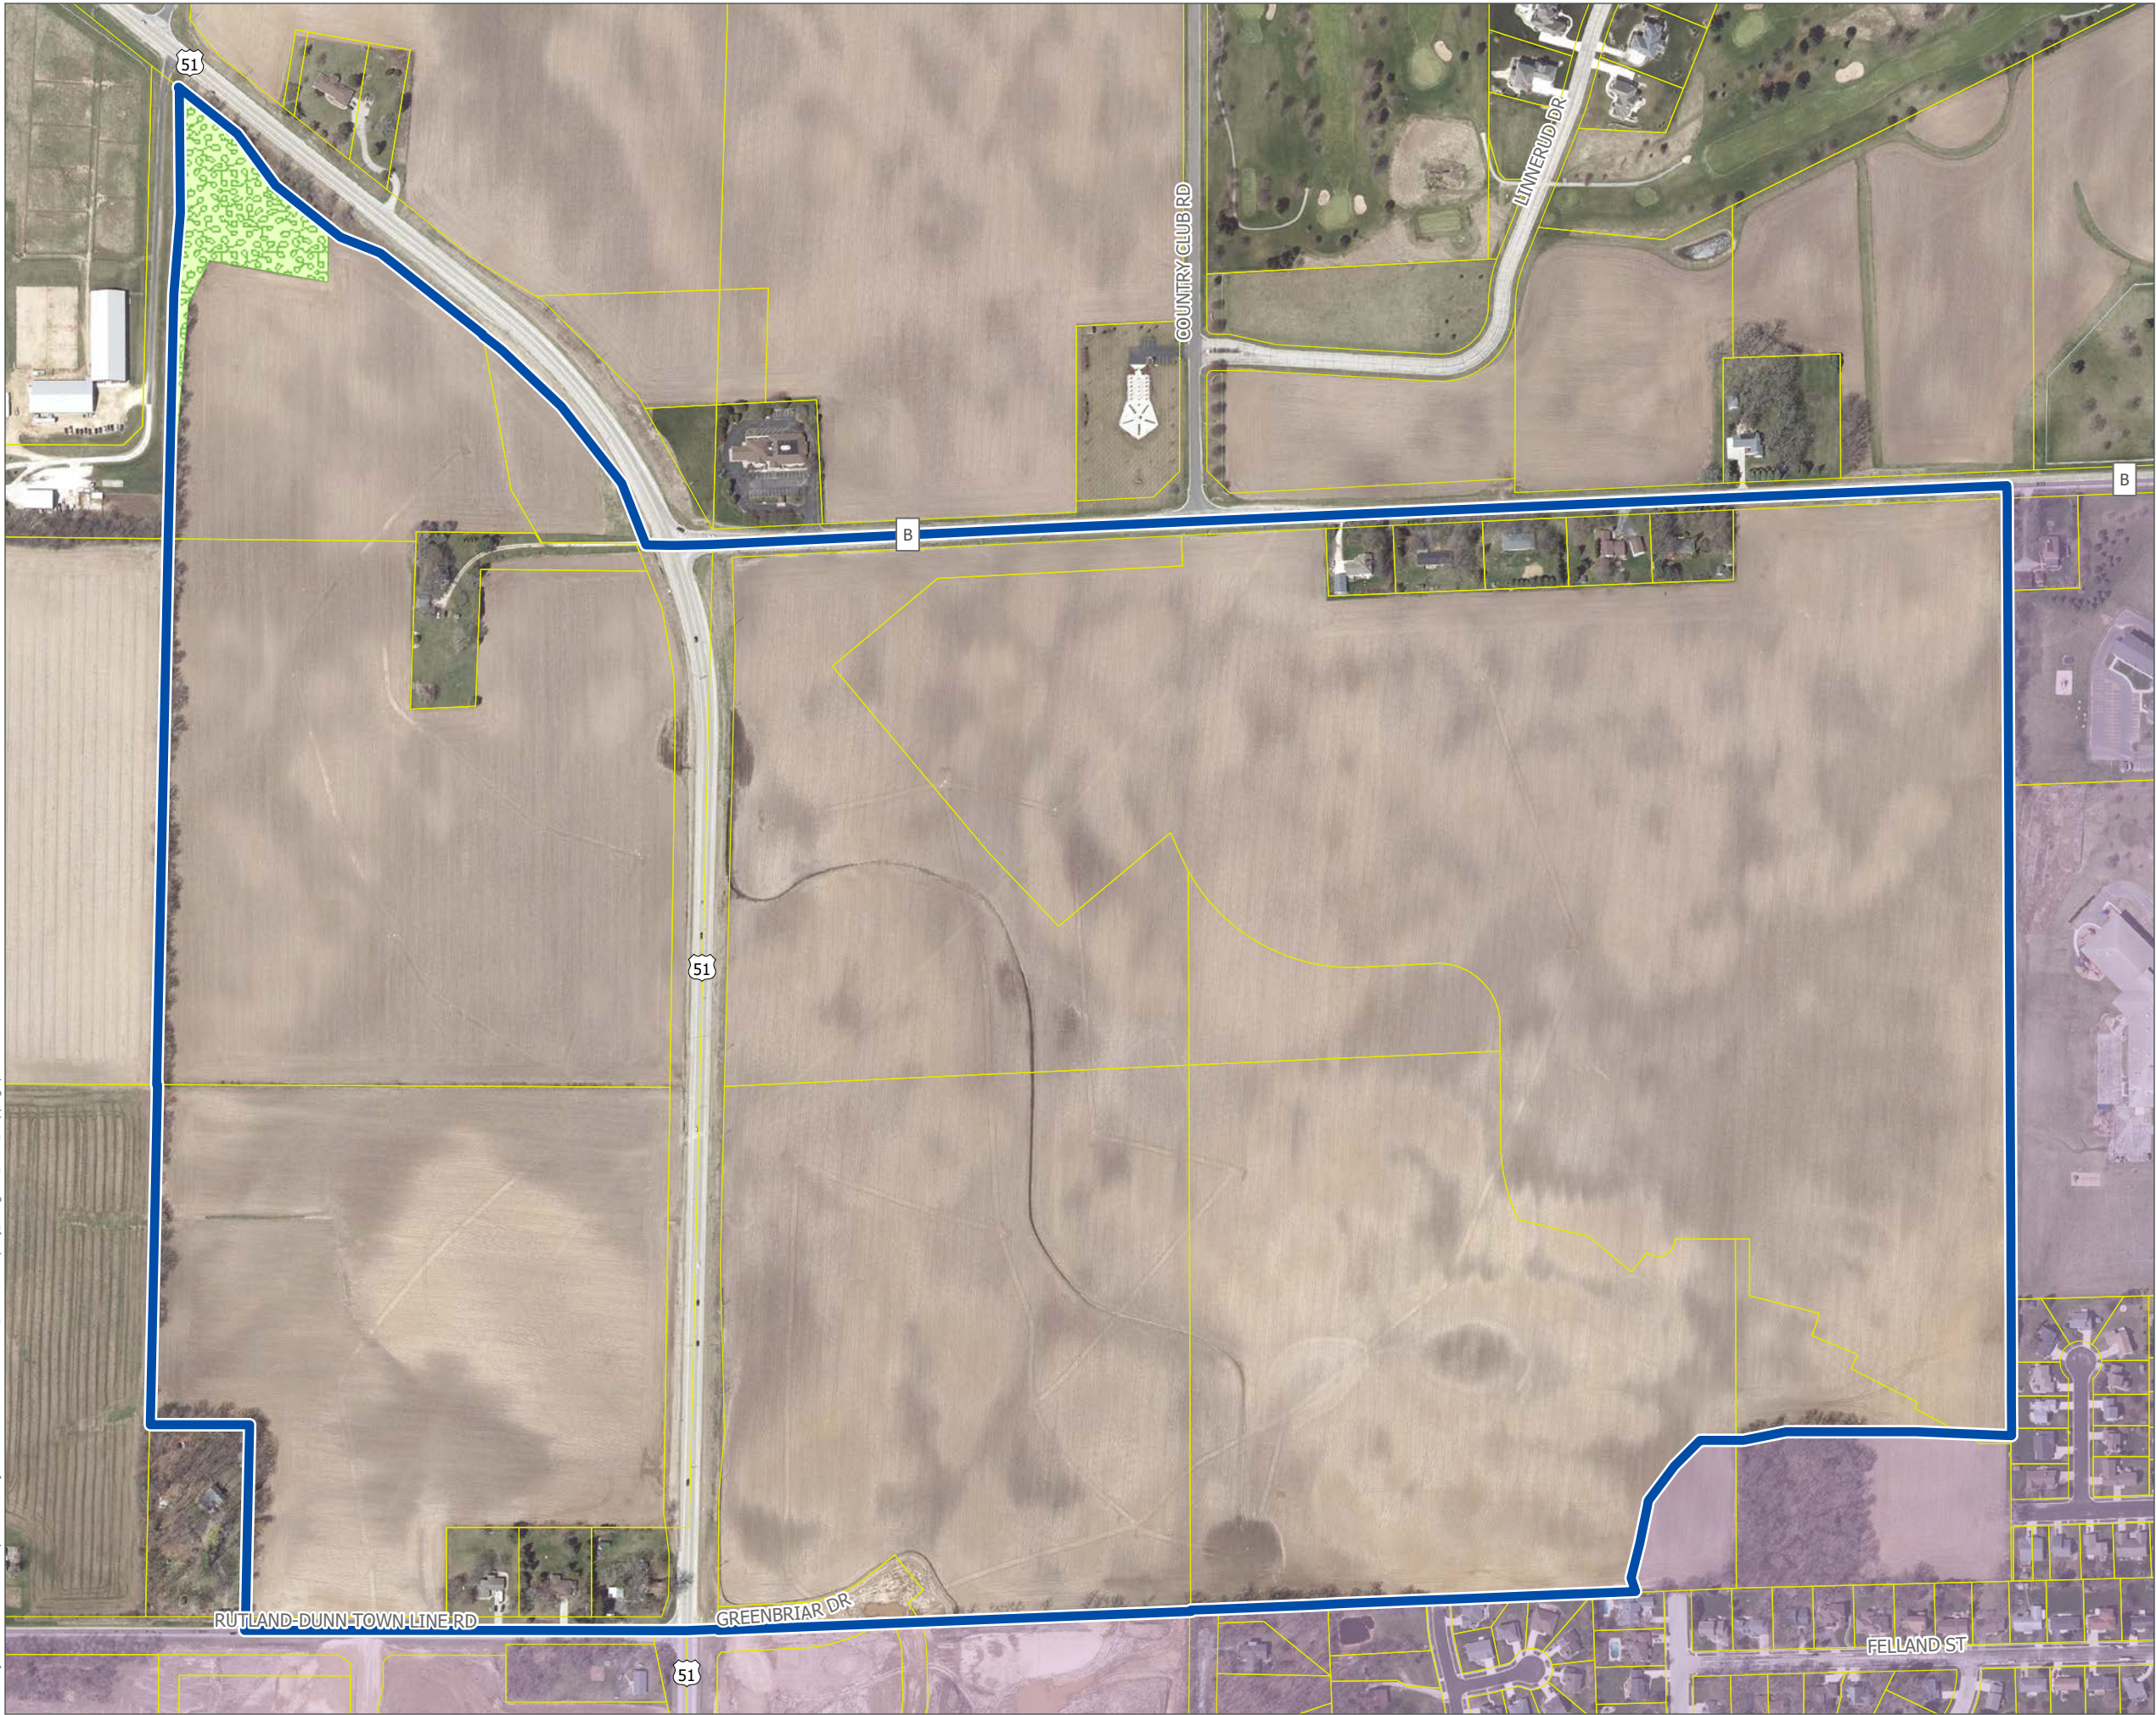
Map 4.1B Woodlands

Woodlands (2.6 Acres)

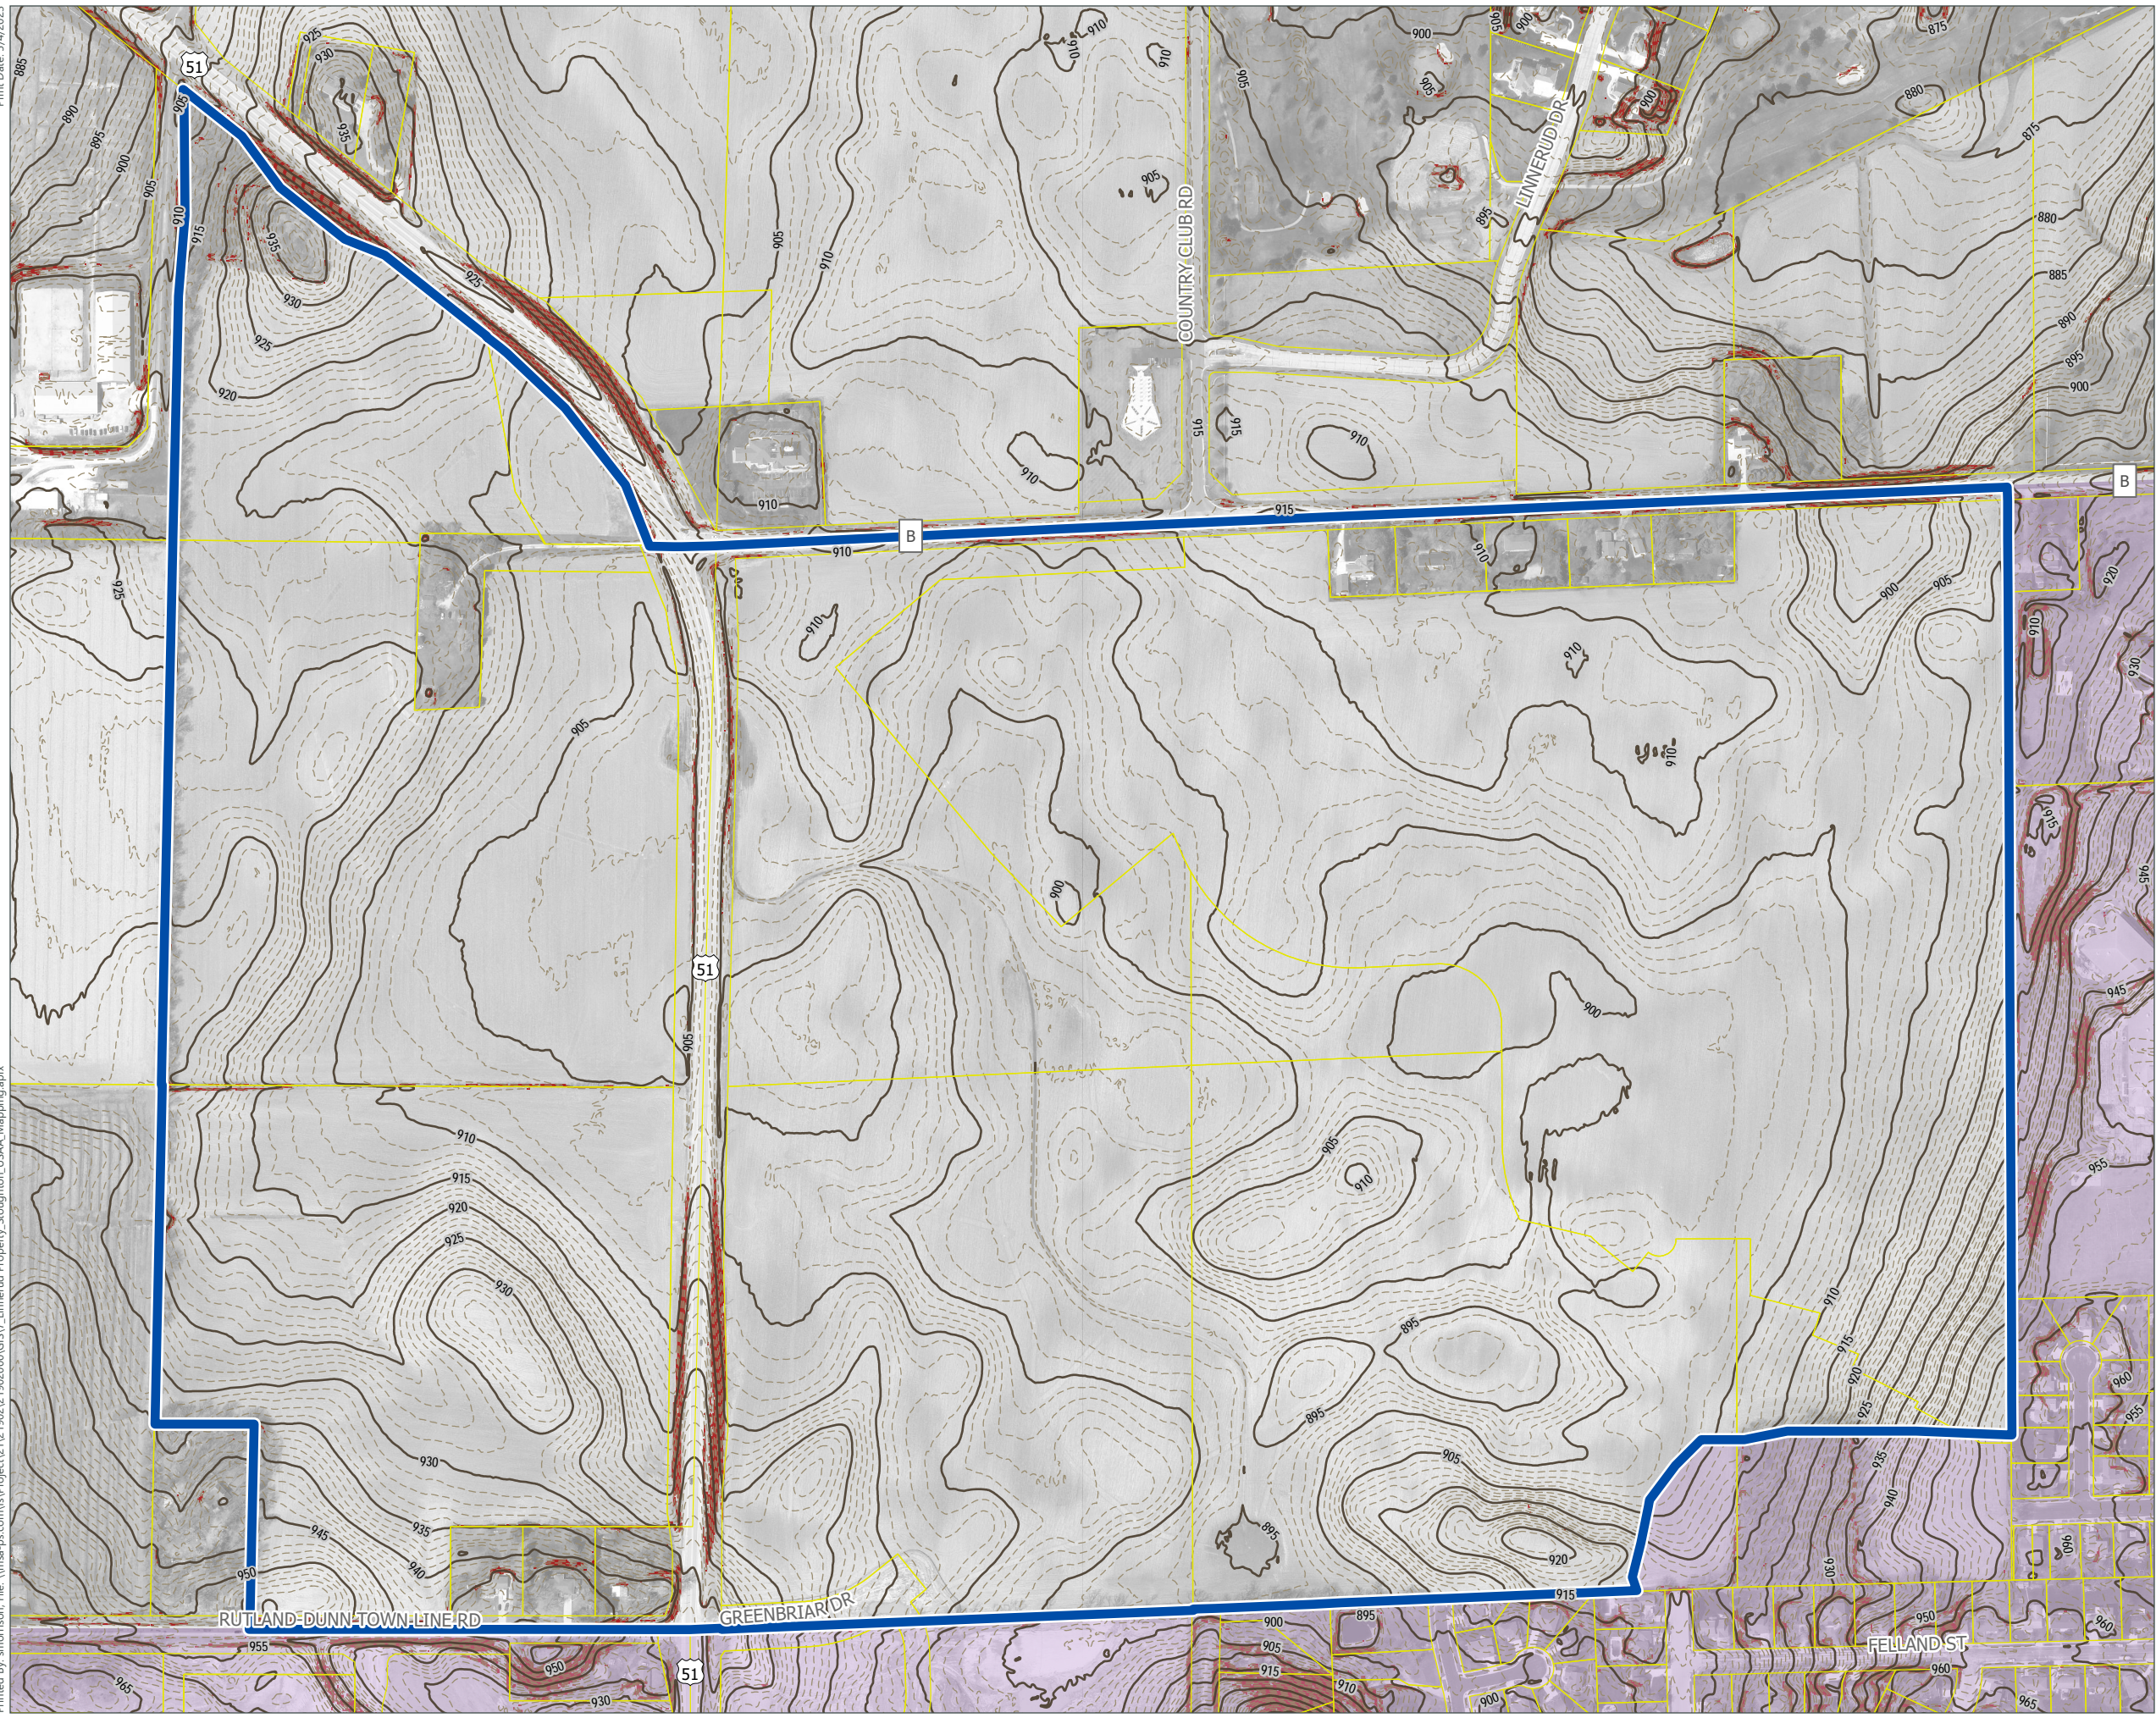
Map 4.1C Contours & Steep Slopes

Data Sources:
Dane County GIS (2023)
Aerial: Dane County (2022)
Contours: Dane County LiDAR (2017)

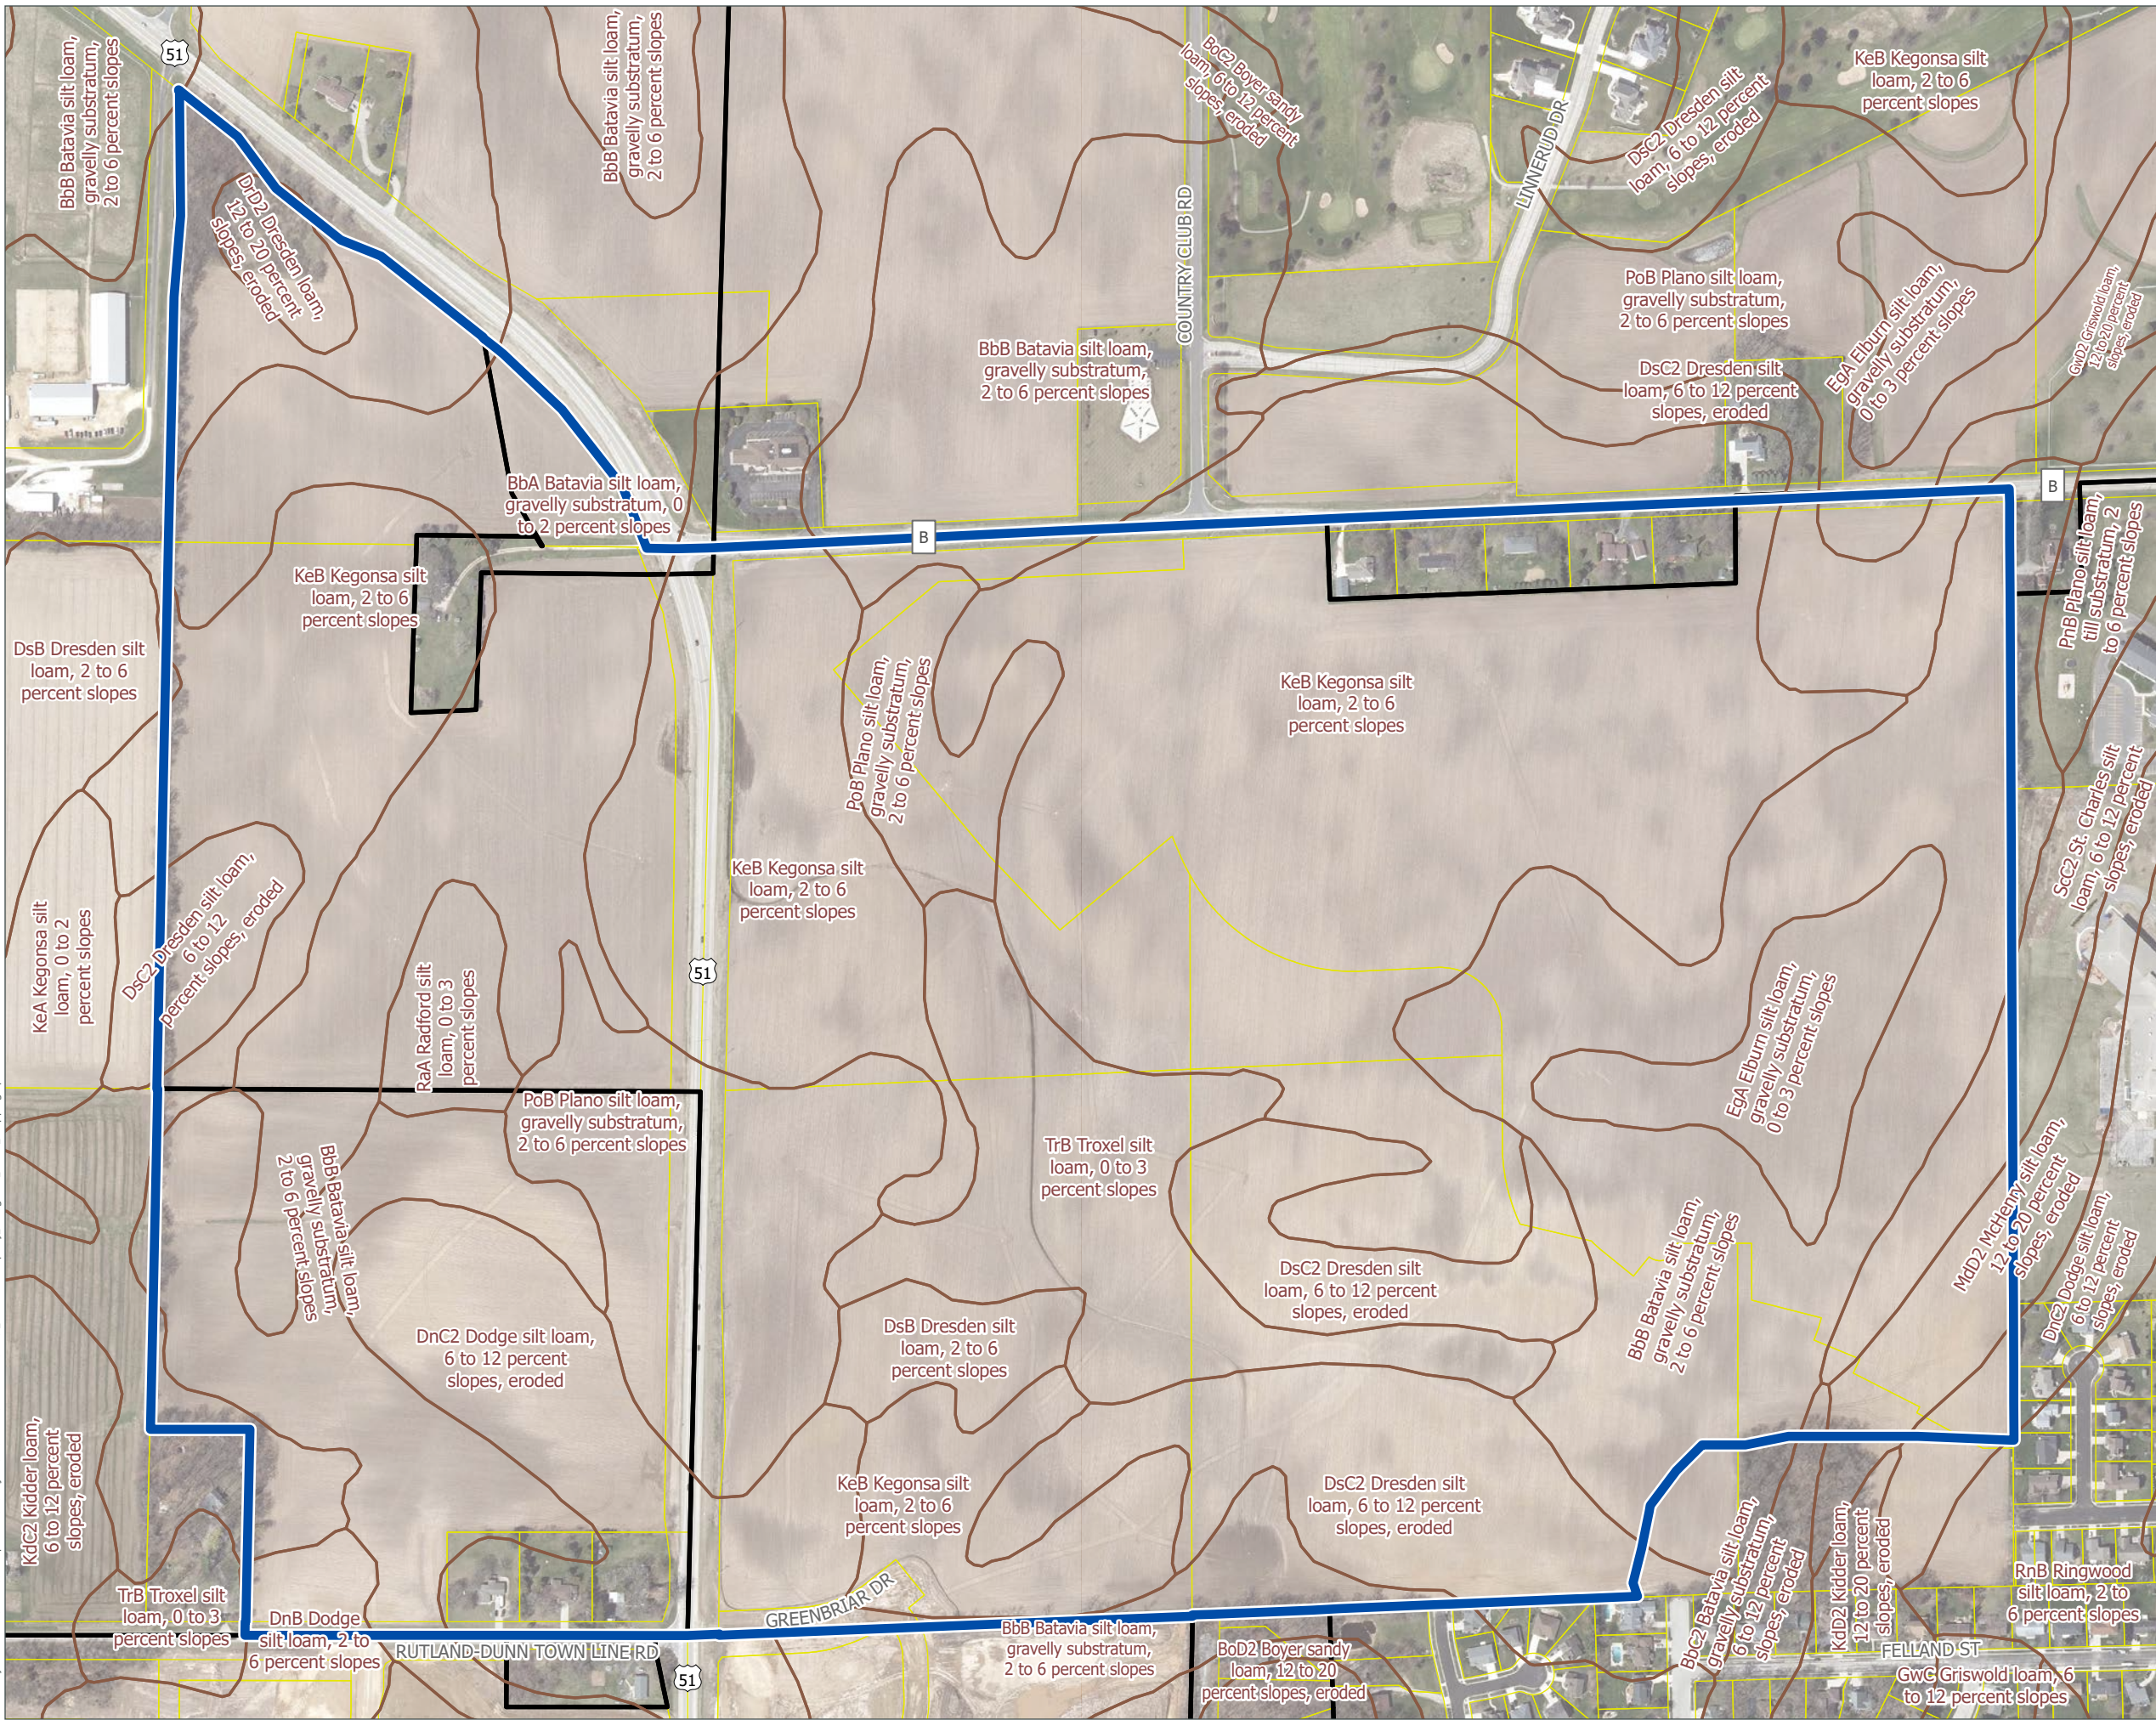
Map 4.1D Soil Types

Data Sources:
Dane County GIS (2023)
Aerial: Dane County (2022)
Soils: NRCS (2022)

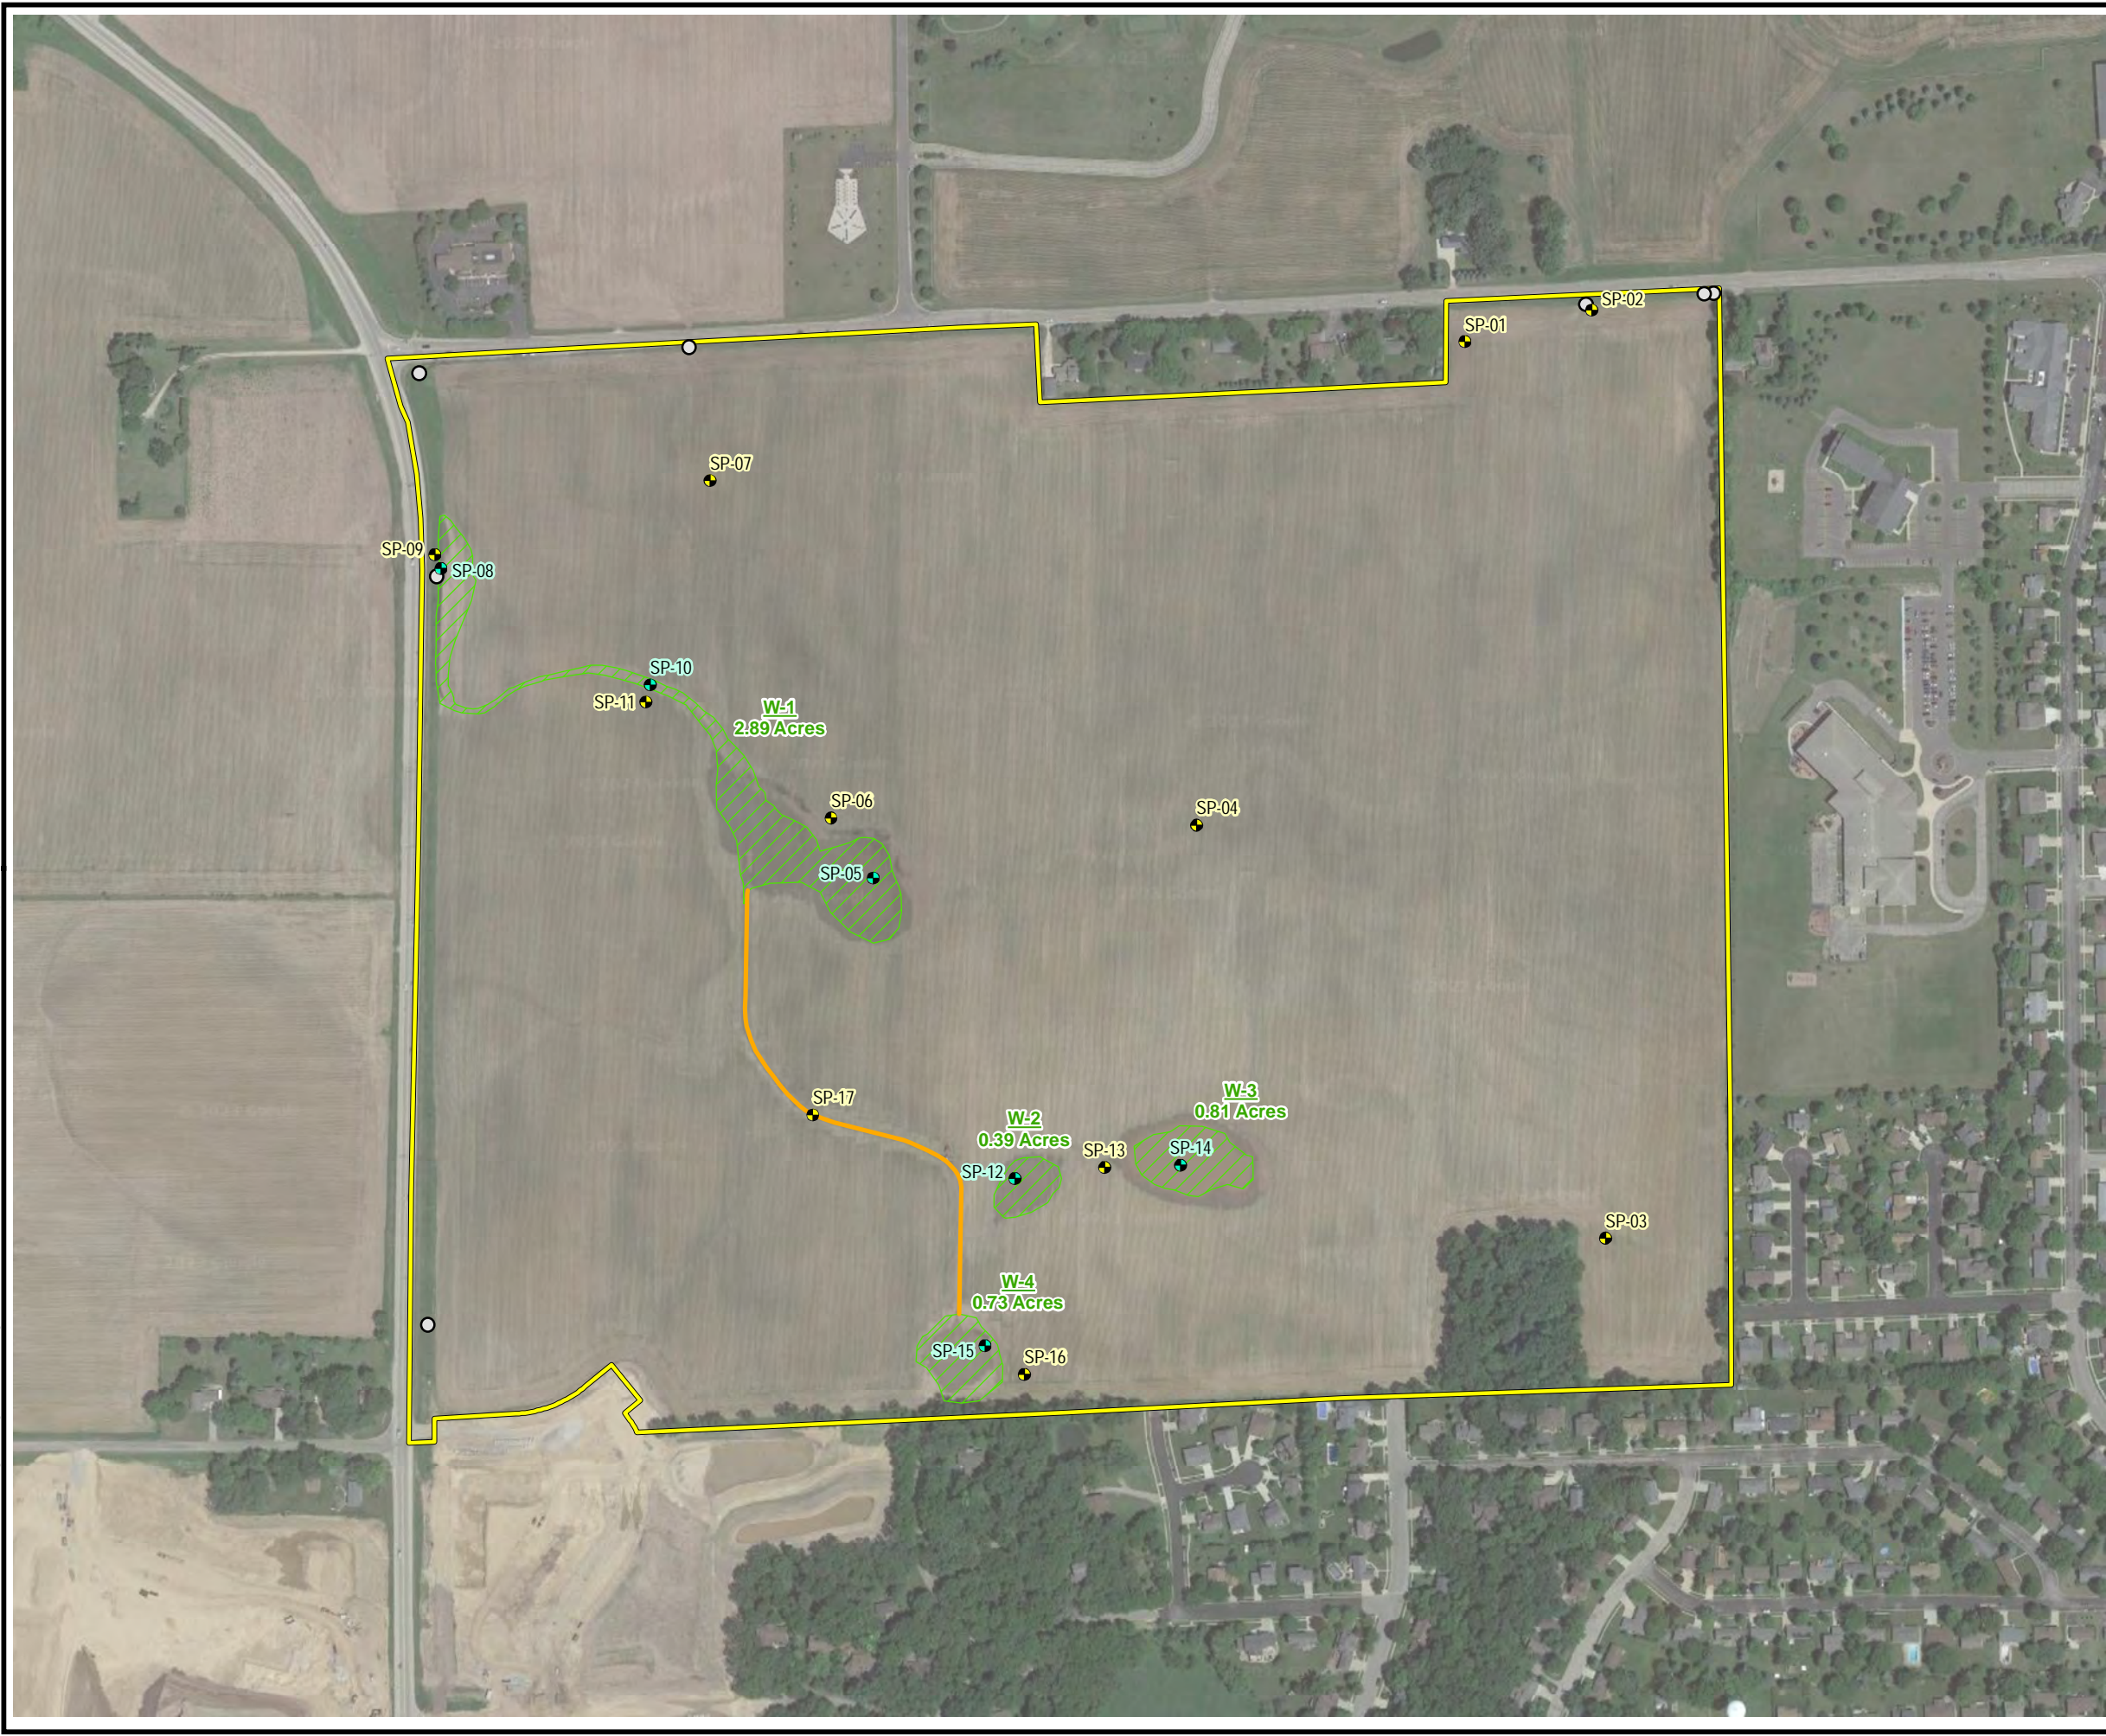
Appendix D:
Wetland and Waterway Delineation Exhibit

- STUDY AREA
- TRC DELINEATED PEM WETLAND
- UPLAND DRAINAGE SWALE
- WETLAND SAMPLE POINT
- UPLAND SAMPLE POINT
- CULVERT
