**NORTHERN URBAN SERVICE AREA AMENDMENT APPLICATION**  
**VILLAGE OF DEFOREST**

Submitted: December 11, 2023

Prepared by: Village of DeForest

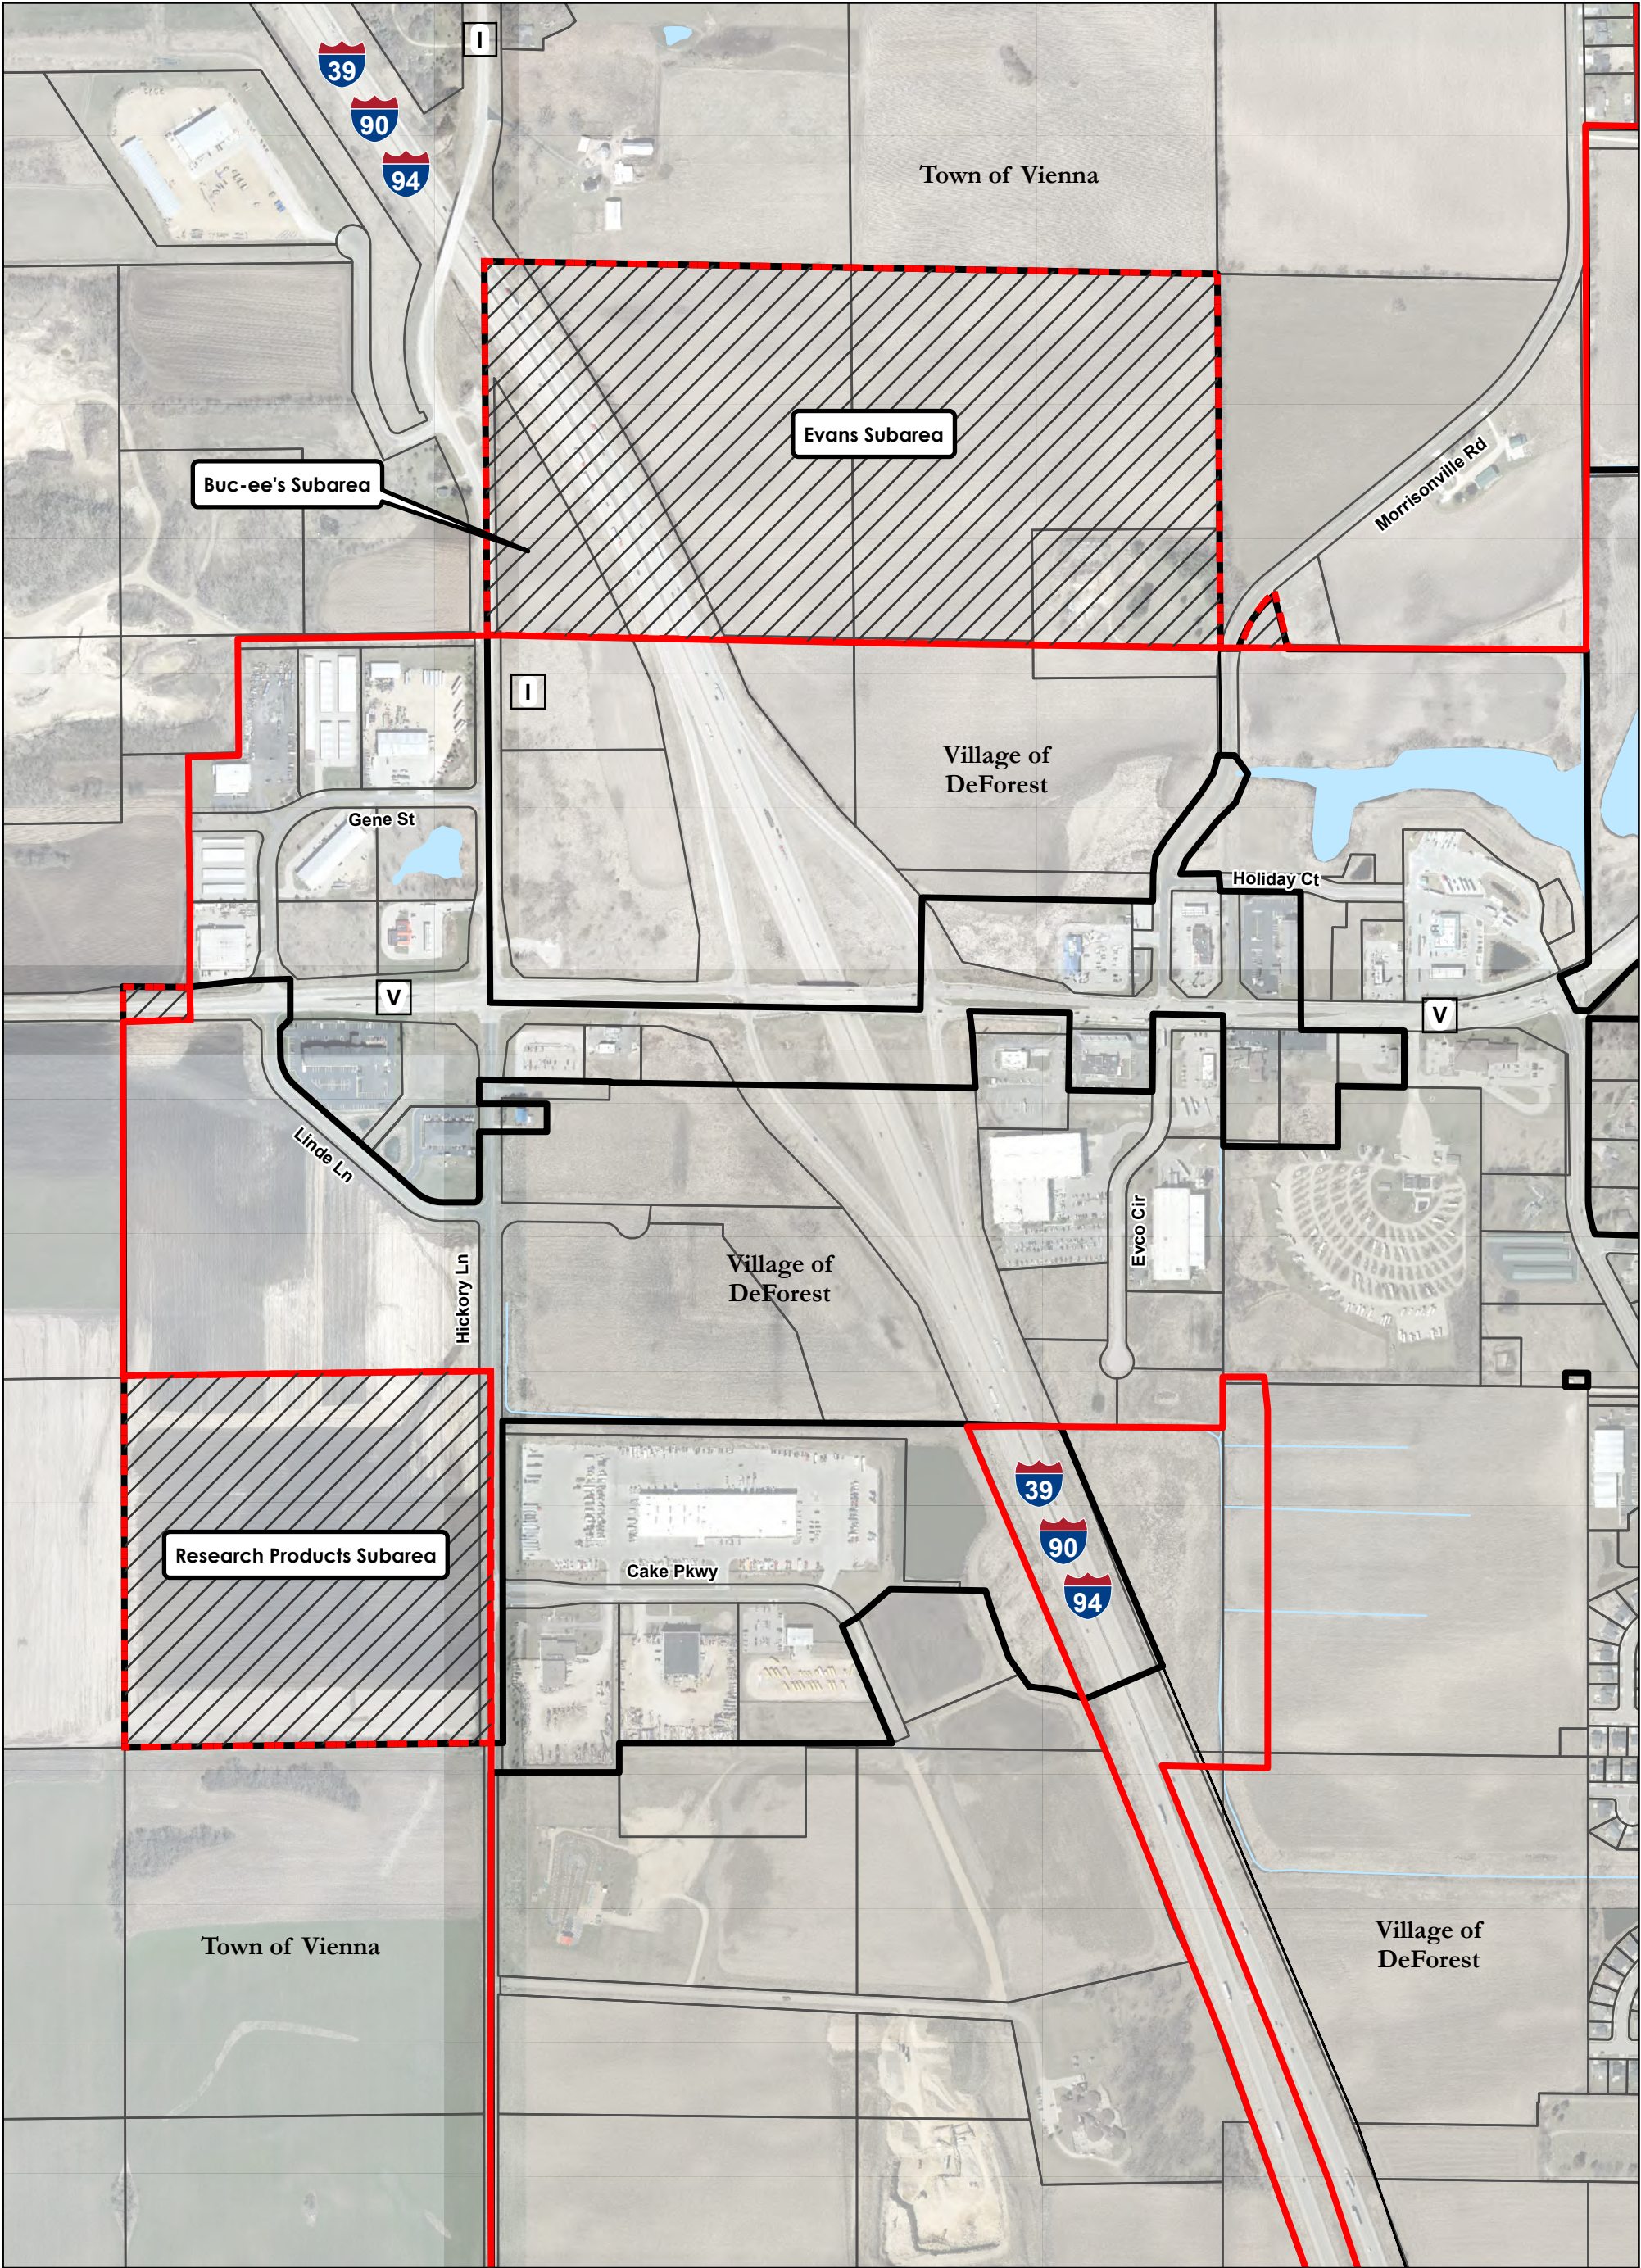
**Map 1**

**Proposed Northern Urban  
Service Area Amendment**

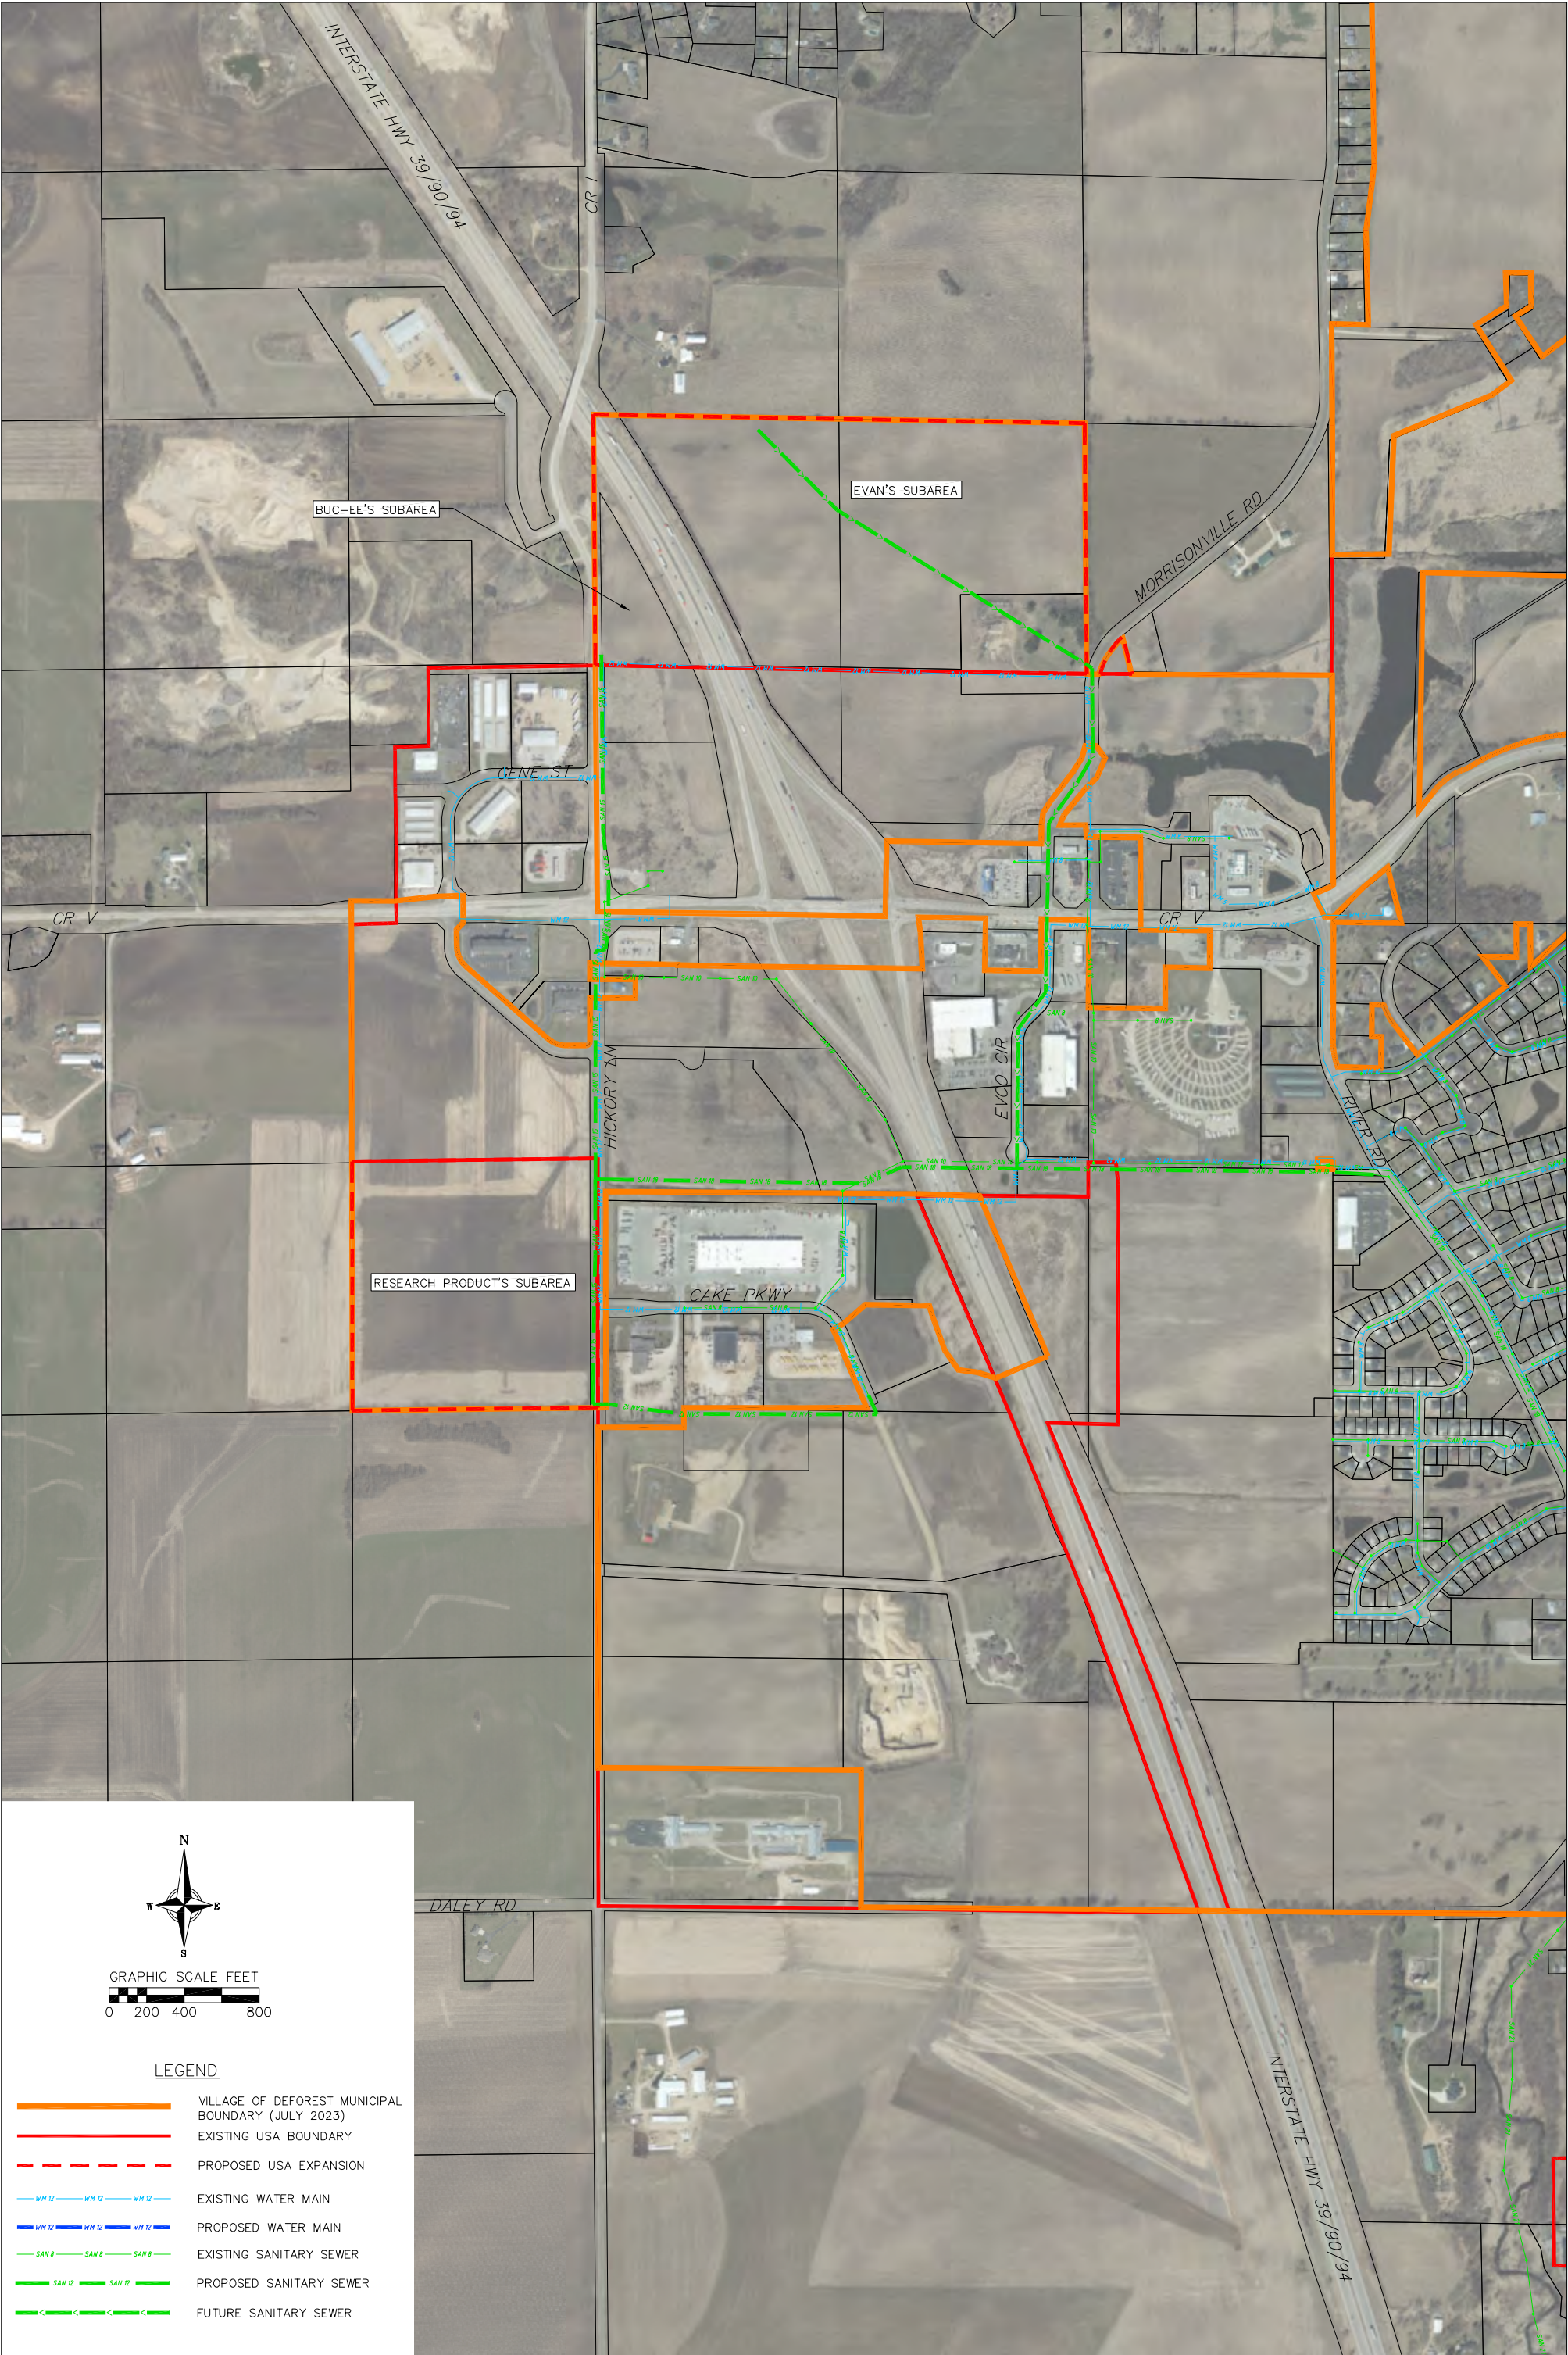
**MAP 7: OVERALL UTILITY SYSTEM CONFIGURATION**  
VILLAGE OF DEFOREST, WISCONSIN  
OCTOBER 31, 2023

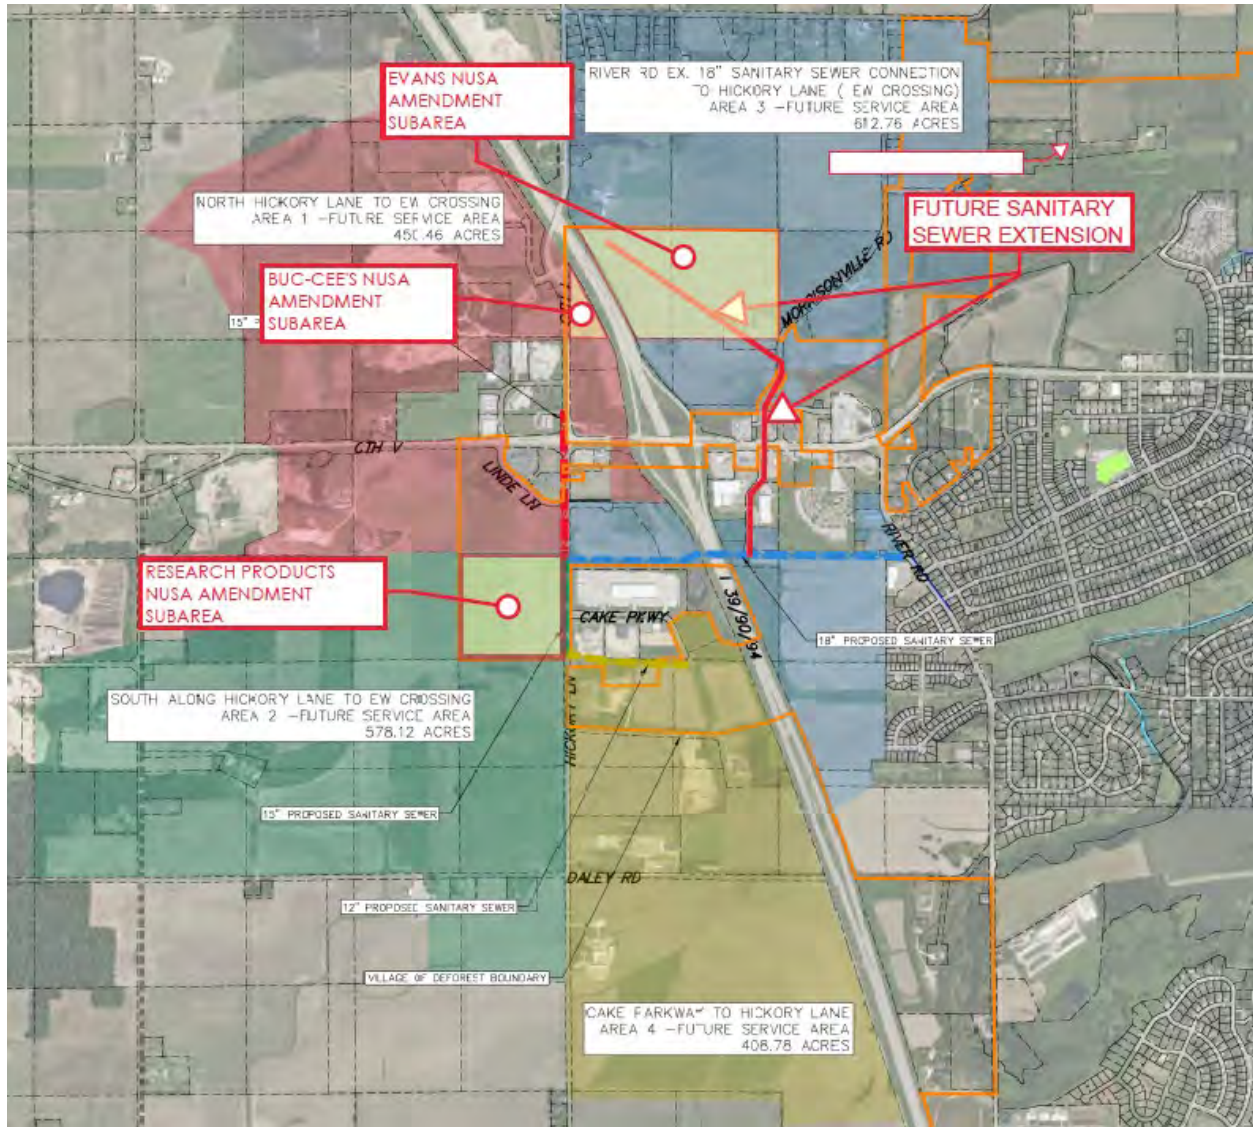
**Map 8: Service Areas for Hickory Lane Sanitary Sewer Interceptors**

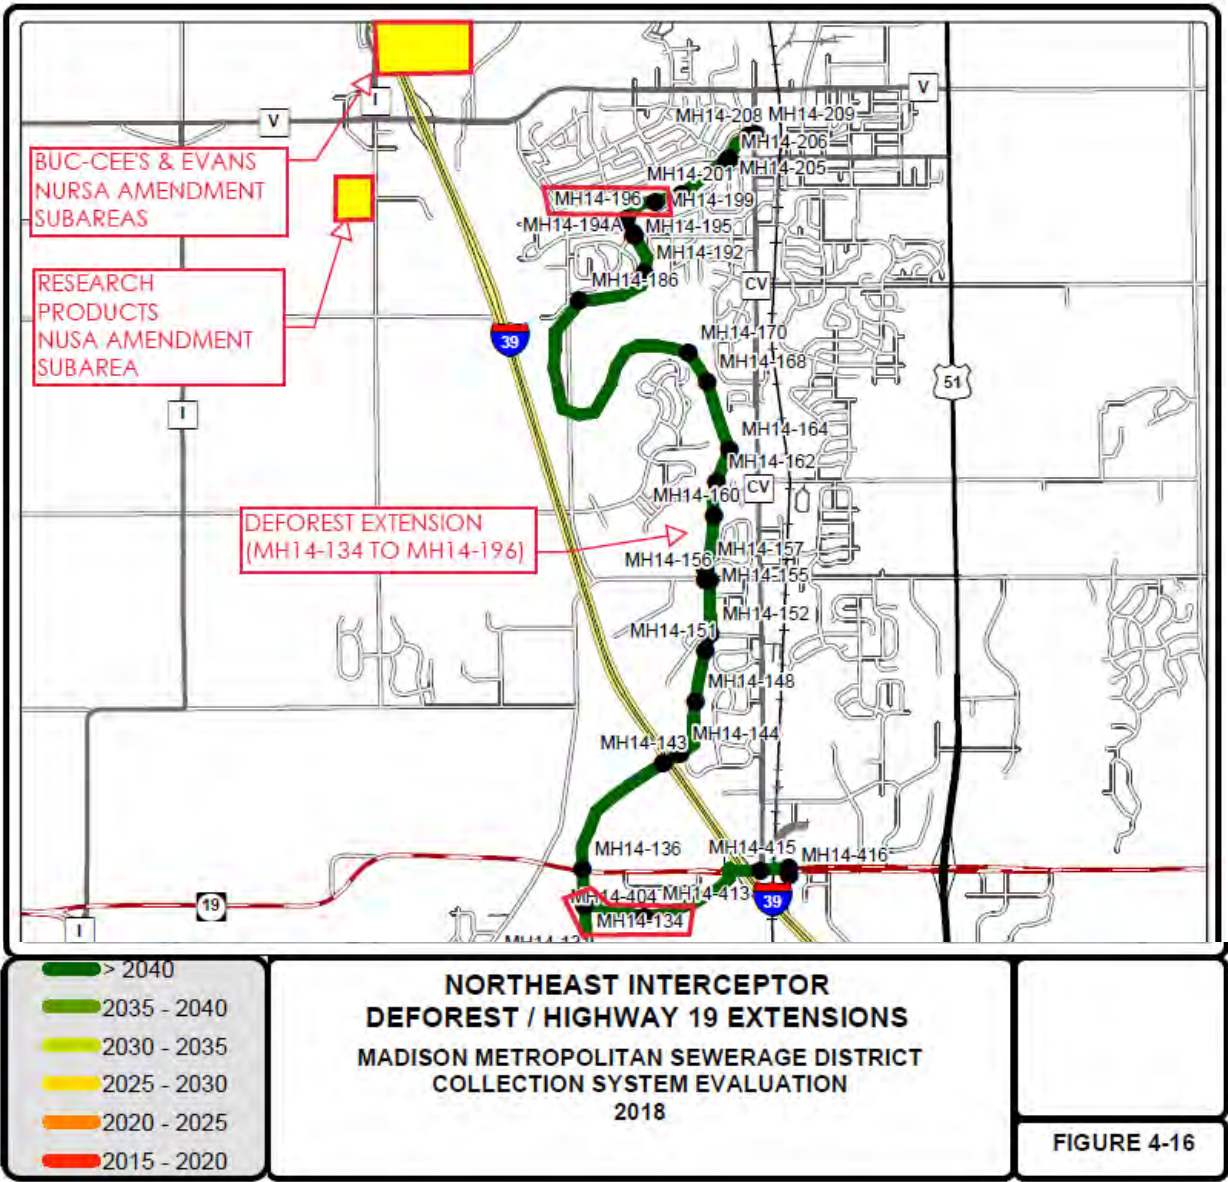
Map 9: MMSD's Northeast Interceptor - DeForest Extension

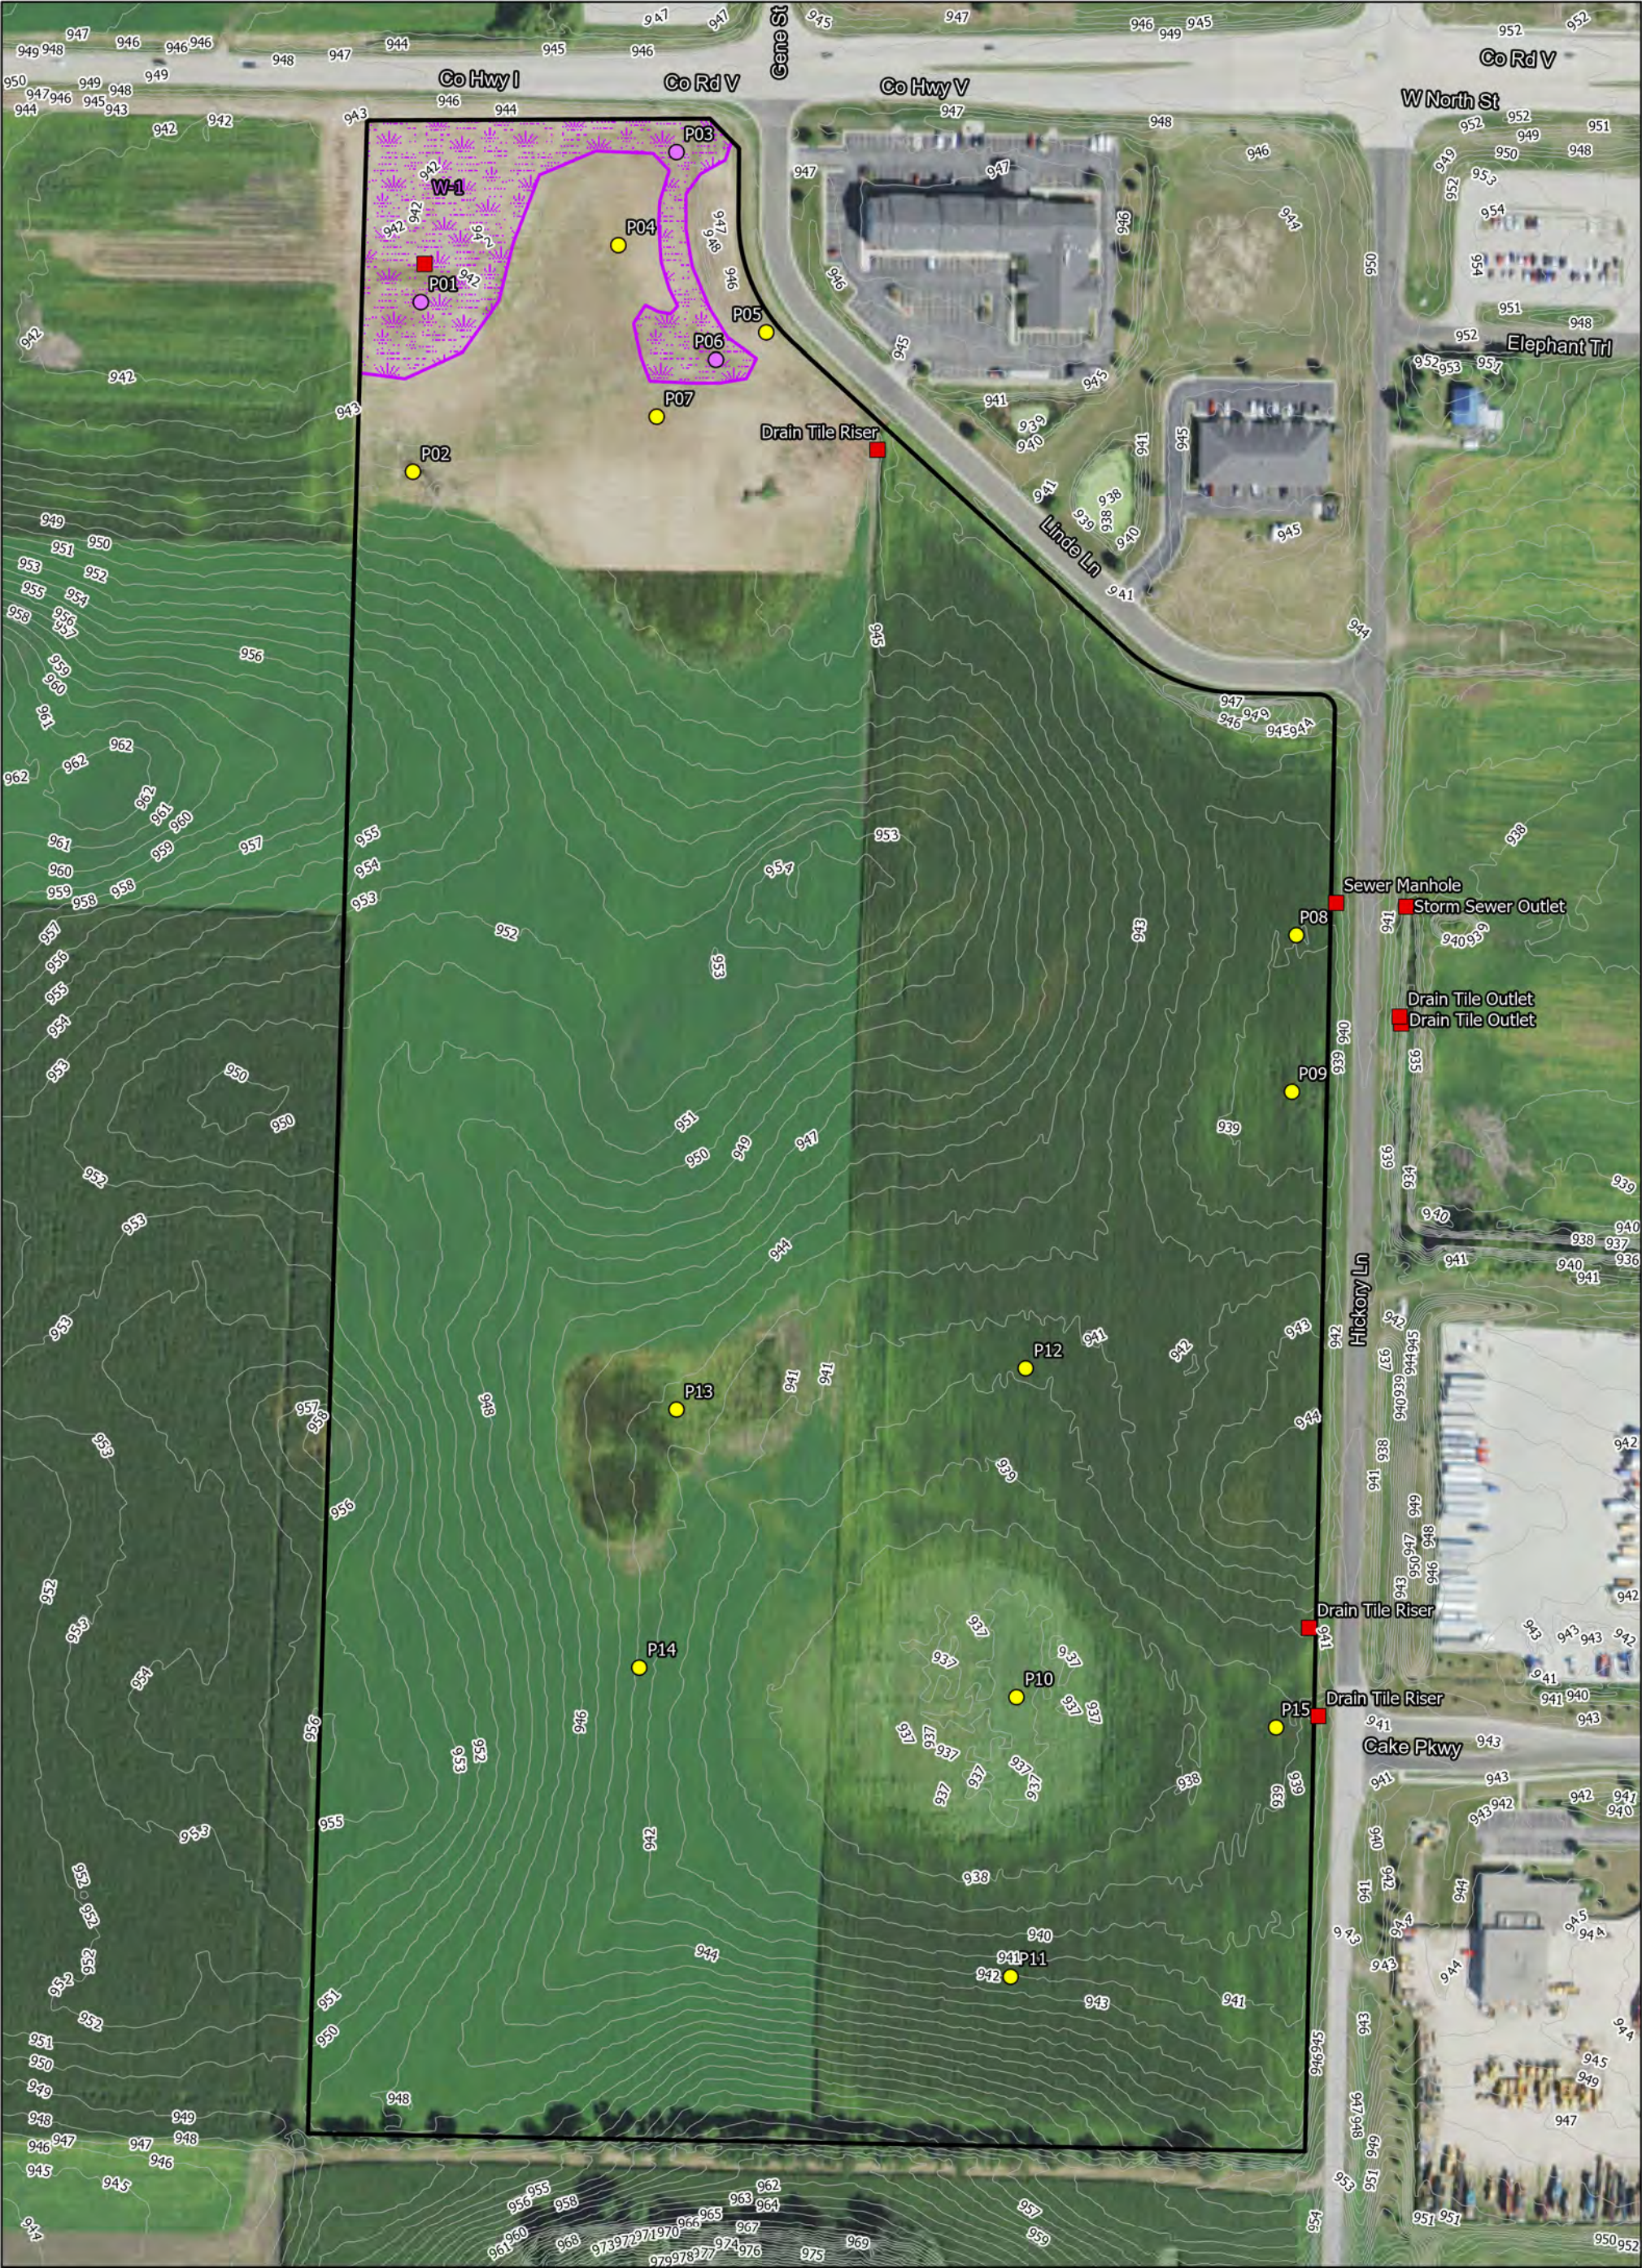
- Study Area (65.57 ac)
- Dane Co 1' Contours
- Drainage Features
- Field Delineated Wetlands (2.09 ac)
- Sample Points**
  - Upland
  - Wetland

One (1) wetland area totaling approximately 2.09 acres was delineated and mapped within the Study Area (Figure 6, Appendix A). Wetlands, waterways, and water bodies discussed in this report may be subject to federal regulation under the jurisdiction of the U.S. Army Corps of Engineers (USACE), state regulation under the jurisdiction of the WDNR, and local zoning authorities. Heartland recommends this report be submitted to local authorities, the WDNR, and USACE for final jurisdictional review and concurrence.

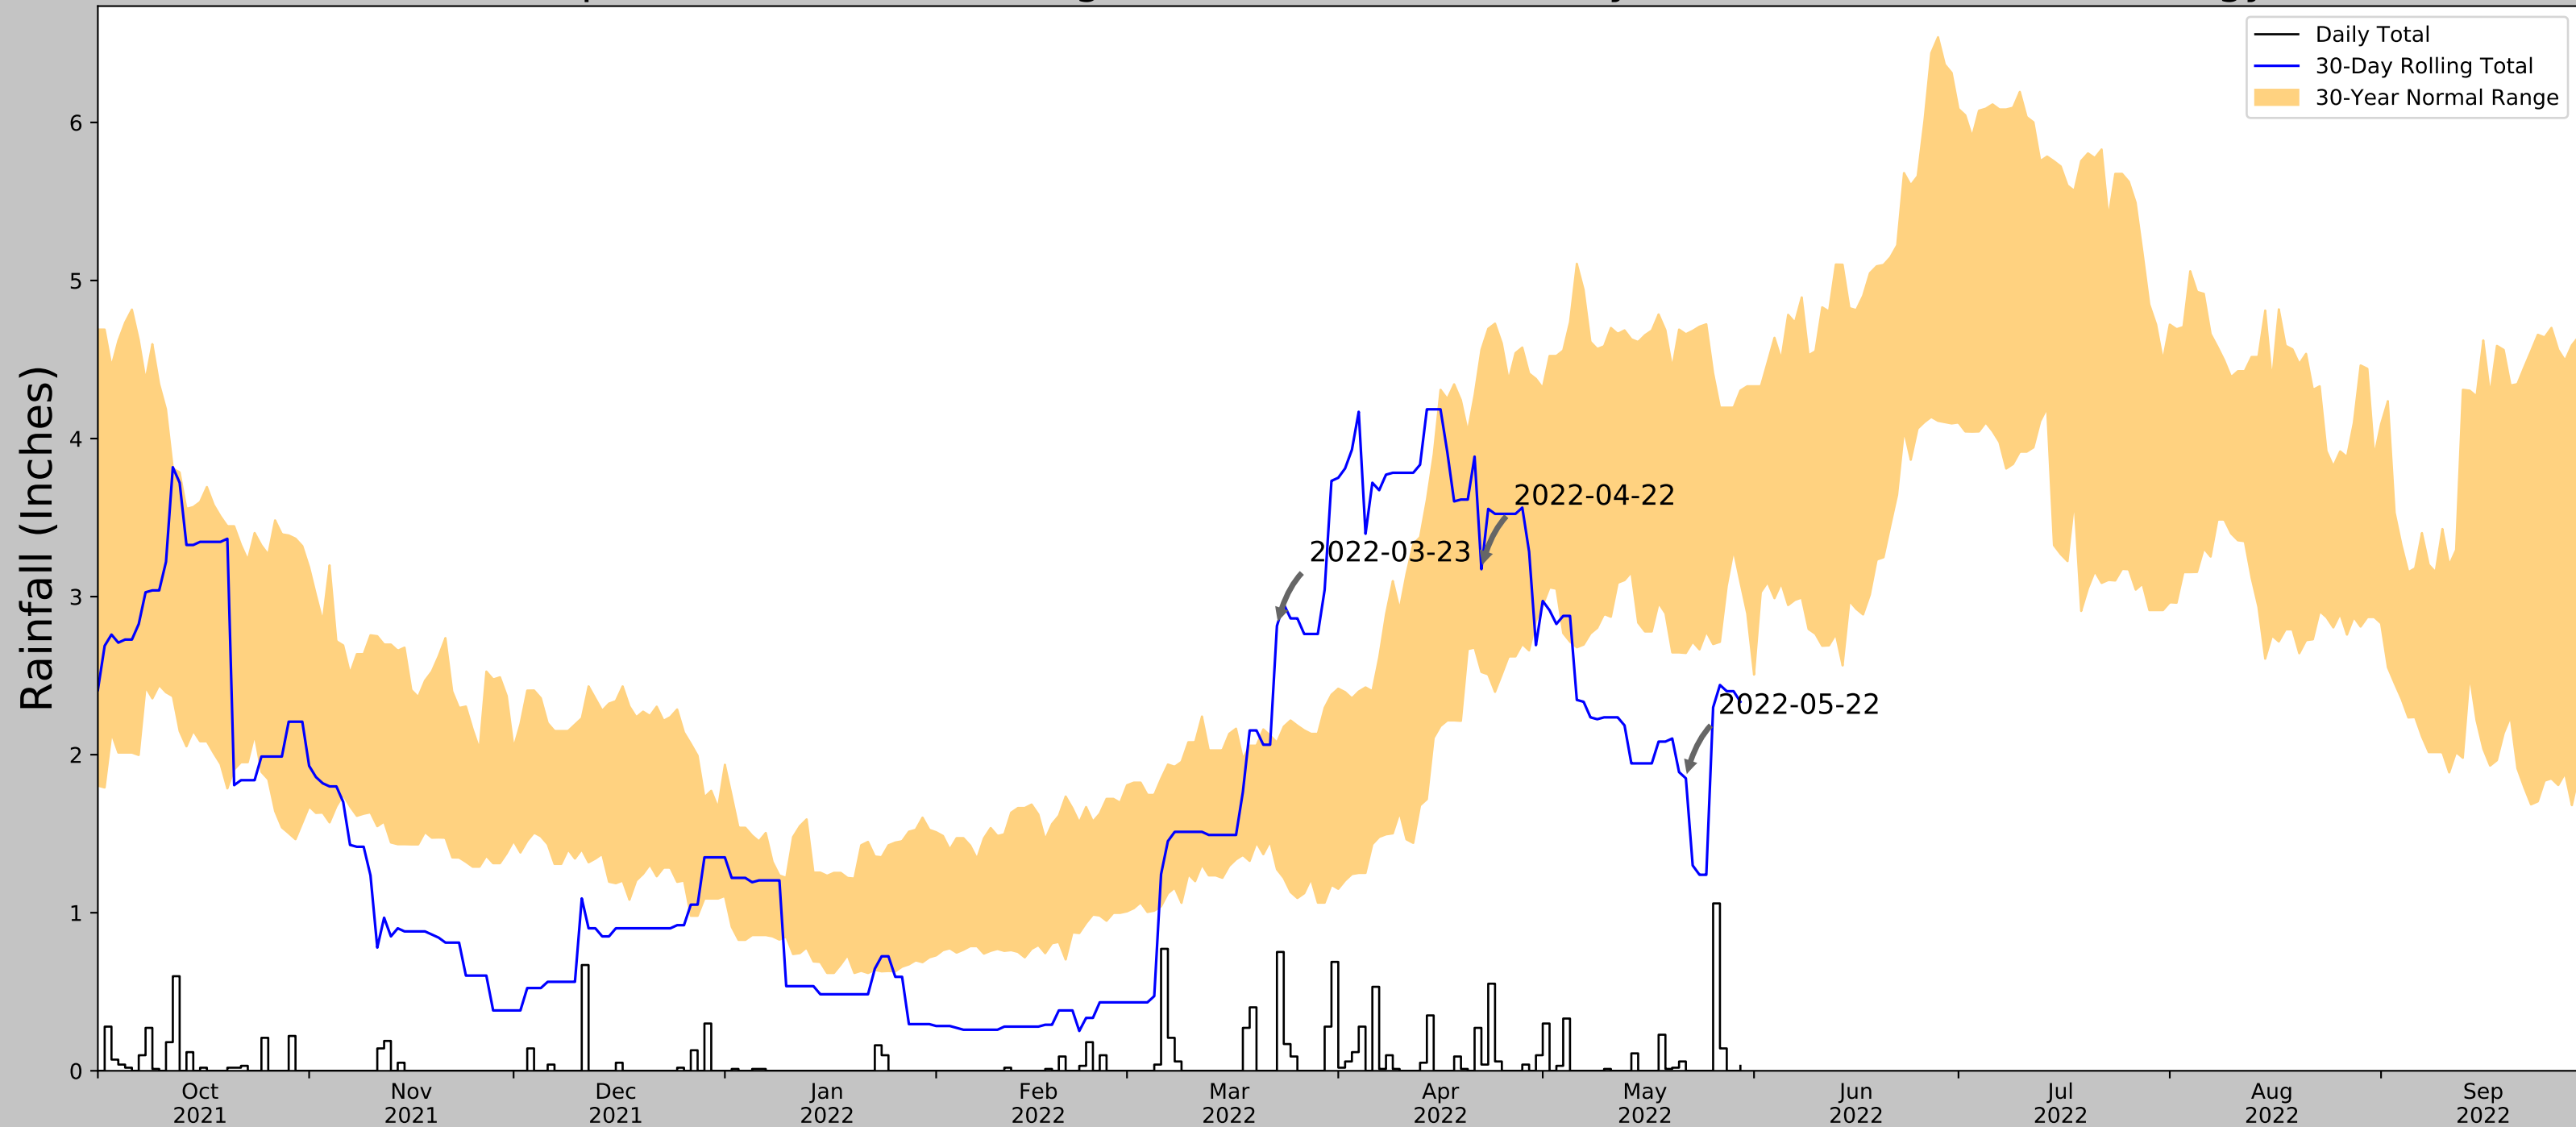
# Antecedent Precipitation vs Normal Range based on NOAA's Daily Global Historical Climatology Network

Coordinates	43.24656, -89.38403
Observation Date	2022-05-22
Elevation (ft)	940.08
Drought Index (PDSI)	Moderate drought (2022-04)
WebWIMP H <sub>2</sub> O Balance	Dry Season

30 Days Ending	30 <sup>th</sup> %ile (in)	70 <sup>th</sup> %ile (in)	Observed (in)	Wetness Condition	Condition Value	Month Weight	Product
2022-05-22	2.642913	4.66063	1.850394	Dry	1	3	3
2022-04-22	2.522835	4.562205	3.173228	Normal	2	2	4
2022-03-23	1.274803	2.076772	2.814961	Wet	3	1	3
Result							Normal Conditions - 10

According to the APT analyses using the previous 90 days of precipitation data, conditions encountered during the May 19<sup>th</sup>, May 23<sup>rd</sup>, June 7<sup>th</sup>, and June 9<sup>th</sup> site visits were expected to be normal for the time of year, while conditions during the July 26<sup>th</sup> site visit were expected to be drier than normal (Appendix B). The Palmer Drought Severity Index was checked as part of the APT analysis, and the long-term conditions at the time of the fieldwork were in the moderate drought to mild drought range. Fieldwork was completed within the dry-season based on long-term regional hydrology data utilized in the WebWIMP Climatic Water Balance and computed as part of the APT analyses.

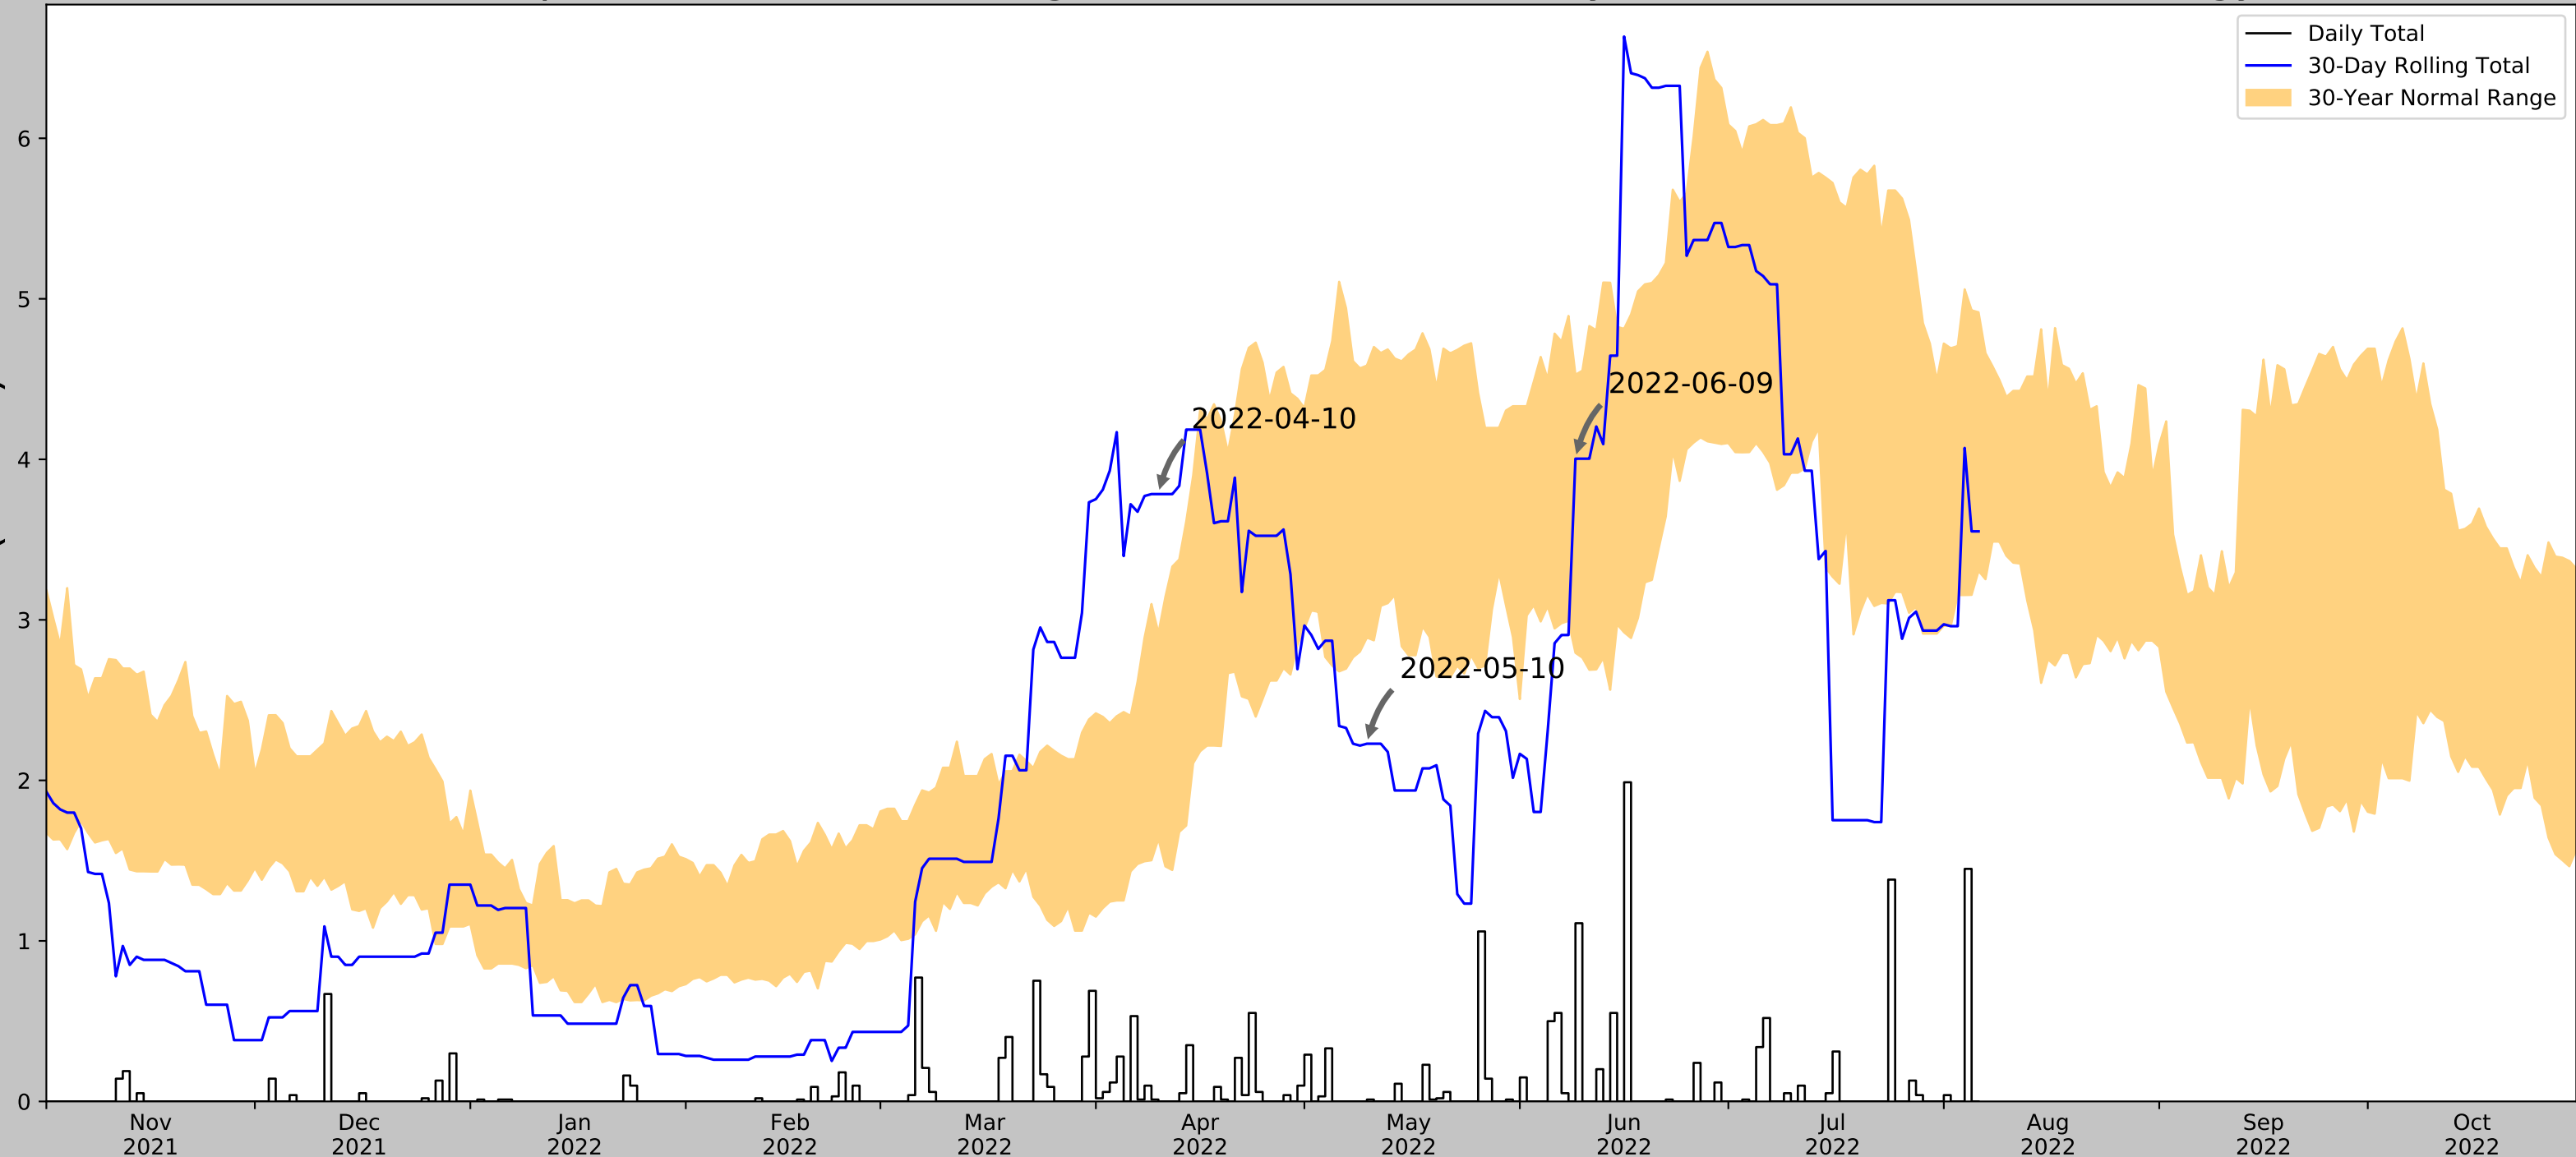
# Antecedent Precipitation vs Normal Range based on NOAA's Daily Global Historical Climatology Network

Coordinates	43.24656, -89.38403
Observation Date	2022-06-09
Elevation (ft)	940.08
Drought Index (PDSI)	Moderate drought
WebWIMP H <sub>2</sub> O Balance	Dry Season

30 Days Ending	30 <sup>th</sup> %ile (in)	70 <sup>th</sup> %ile (in)	Observed (in)	Wetness Condition	Condition Value	Month Weight	Product
2022-06-09	2.794488	4.527165	4.003937	Normal	2	3	6
2022-05-10	2.889764	4.584252	2.228347	Dry	1	2	2
2022-04-10	1.635433	2.917717	3.783465	Wet	3	1	3
Result							Normal Conditions - 11
