**NORTHERN URBAN SERVICE AREA AMENDMENT APPLICATION**  
**VILLAGE OF DEFOREST**

Submitted: December 11, 2023

Prepared by: Village of DeForest

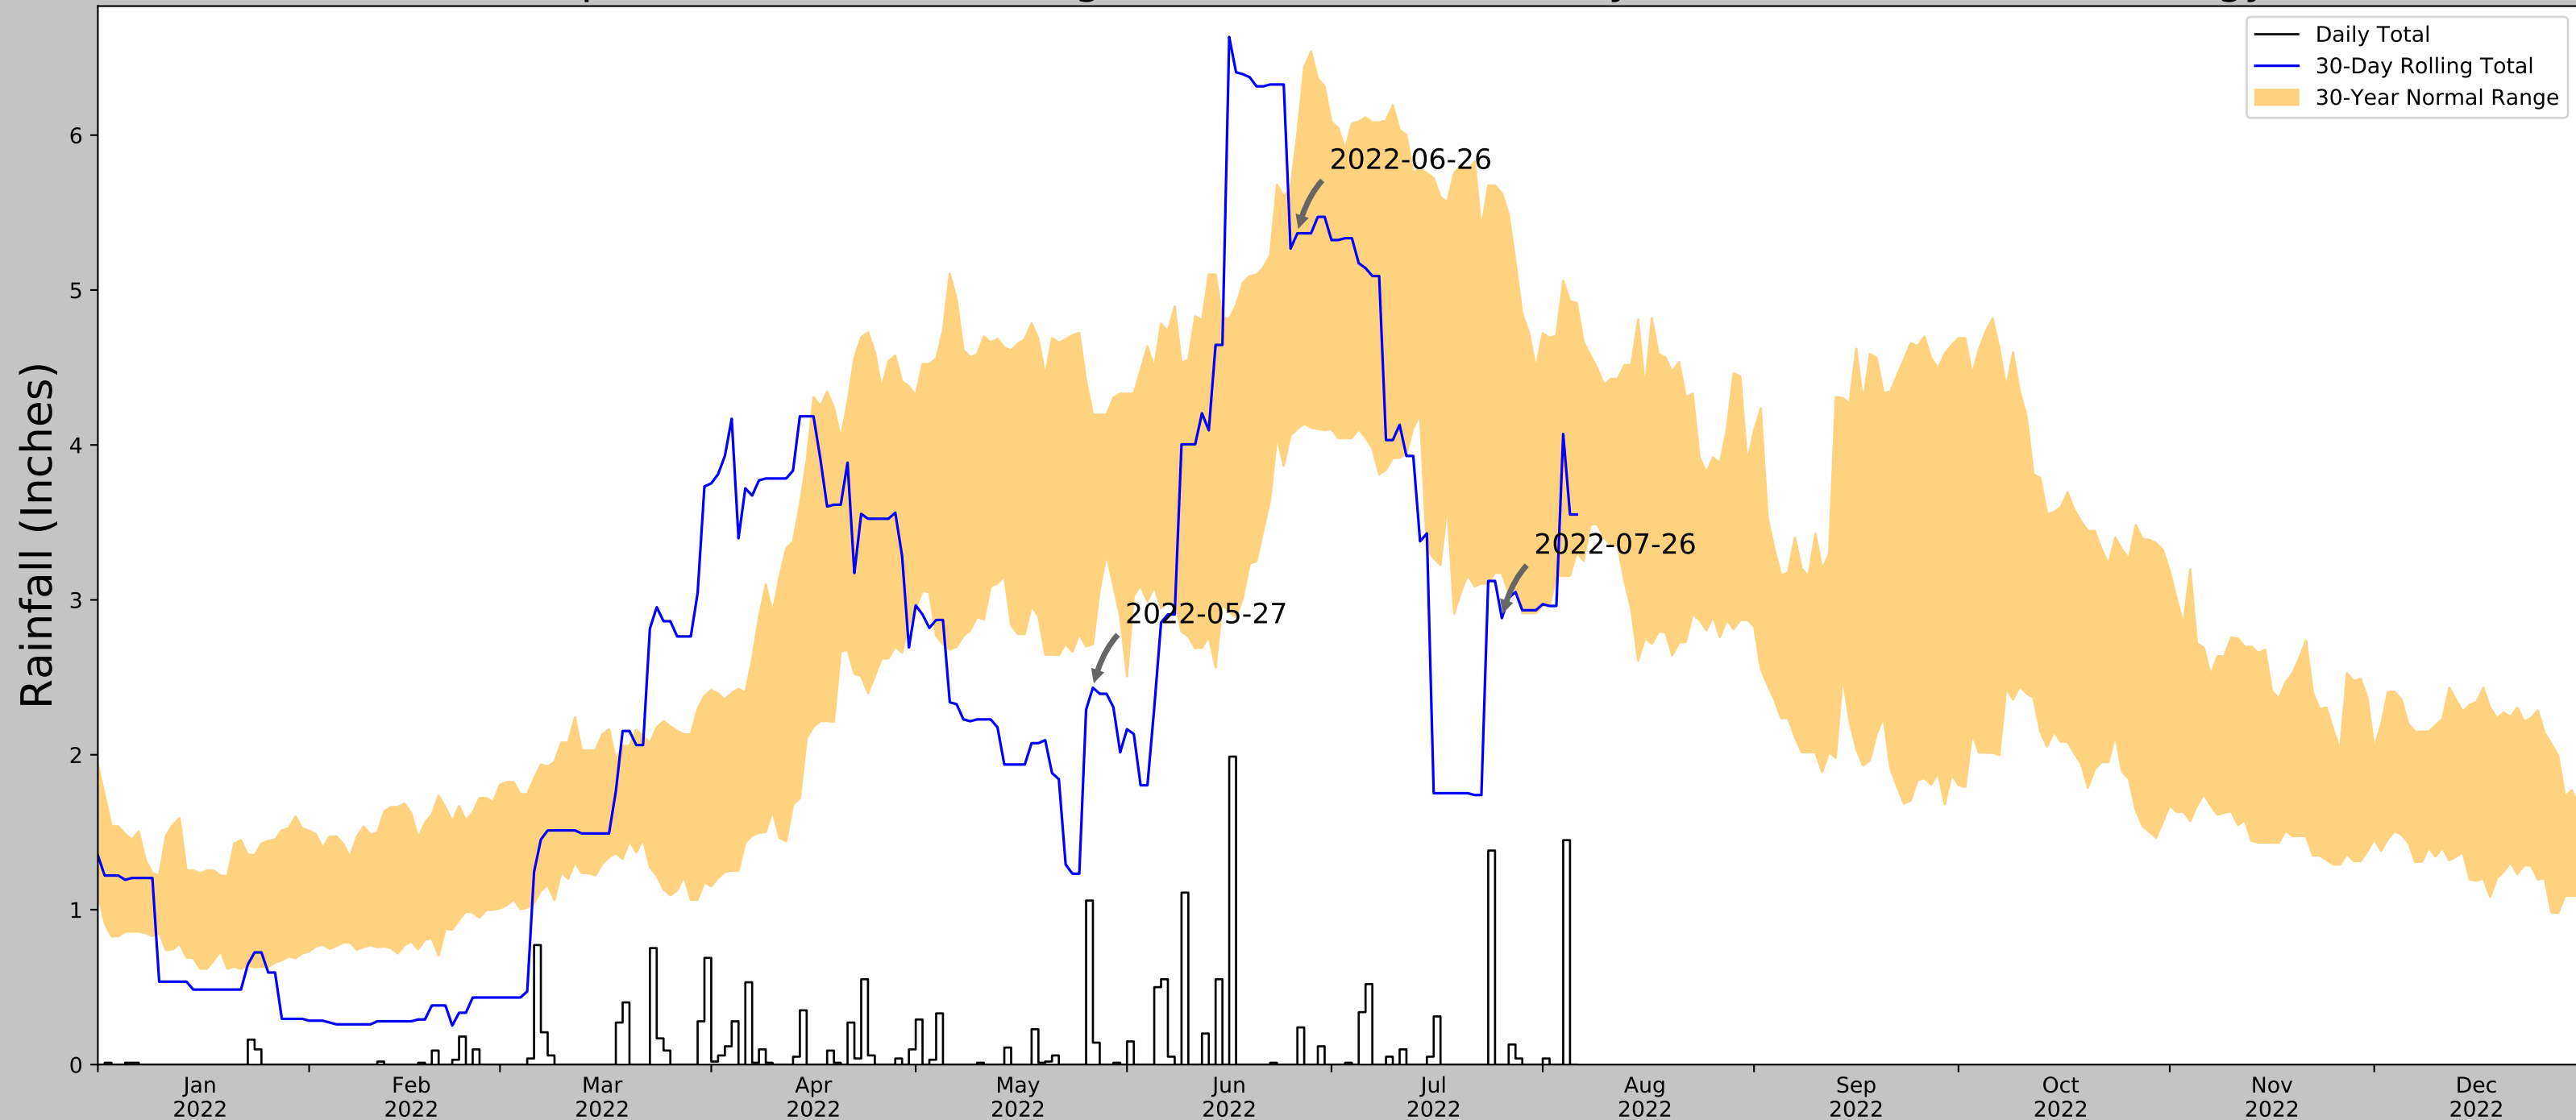
# Antecedent Precipitation vs Normal Range based on NOAA's Daily Global Historical Climatology Network

Coordinates	43.24656, -89.38403
Observation Date	2022-07-26
Elevation (ft)	940.08
Drought Index (PDSI)	Mild drought
WebWIMP H <sub>2</sub> O Balance	Dry Season

30 Days Ending	30 <sup>th</sup> %ile (in)	70 <sup>th</sup> %ile (in)	Observed (in)	Wetness Condition	Condition Value	Month Weight	Product
2022-07-26	3.172441	5.624803	2.88189	Dry	1	3	3
2022-06-26	4.103937	6.011418	5.366142	Normal	2	2	4
2022-05-27	2.713386	4.196063	2.433071	Dry	1	1	1
Result							Drier than Normal - 8

According to the APT analyses using the previous 90 days of precipitation data, conditions encountered during the May 19<sup>th</sup>, May 23<sup>rd</sup>, June 7<sup>th</sup>, and June 9<sup>th</sup> site visits were expected to be normal for the time of year, while conditions during the July 26<sup>th</sup> site visit were expected to be drier than normal (Appendix B). The Palmer Drought Severity Index was checked as part of the APT analysis, and the long-term conditions at the time of the fieldwork were in the moderate drought to mild drought range. Fieldwork was completed within the dry-season based on long-term regional hydrology data utilized in the WebWIMP Climatic Water Balance and computed as part of the APT analyses.

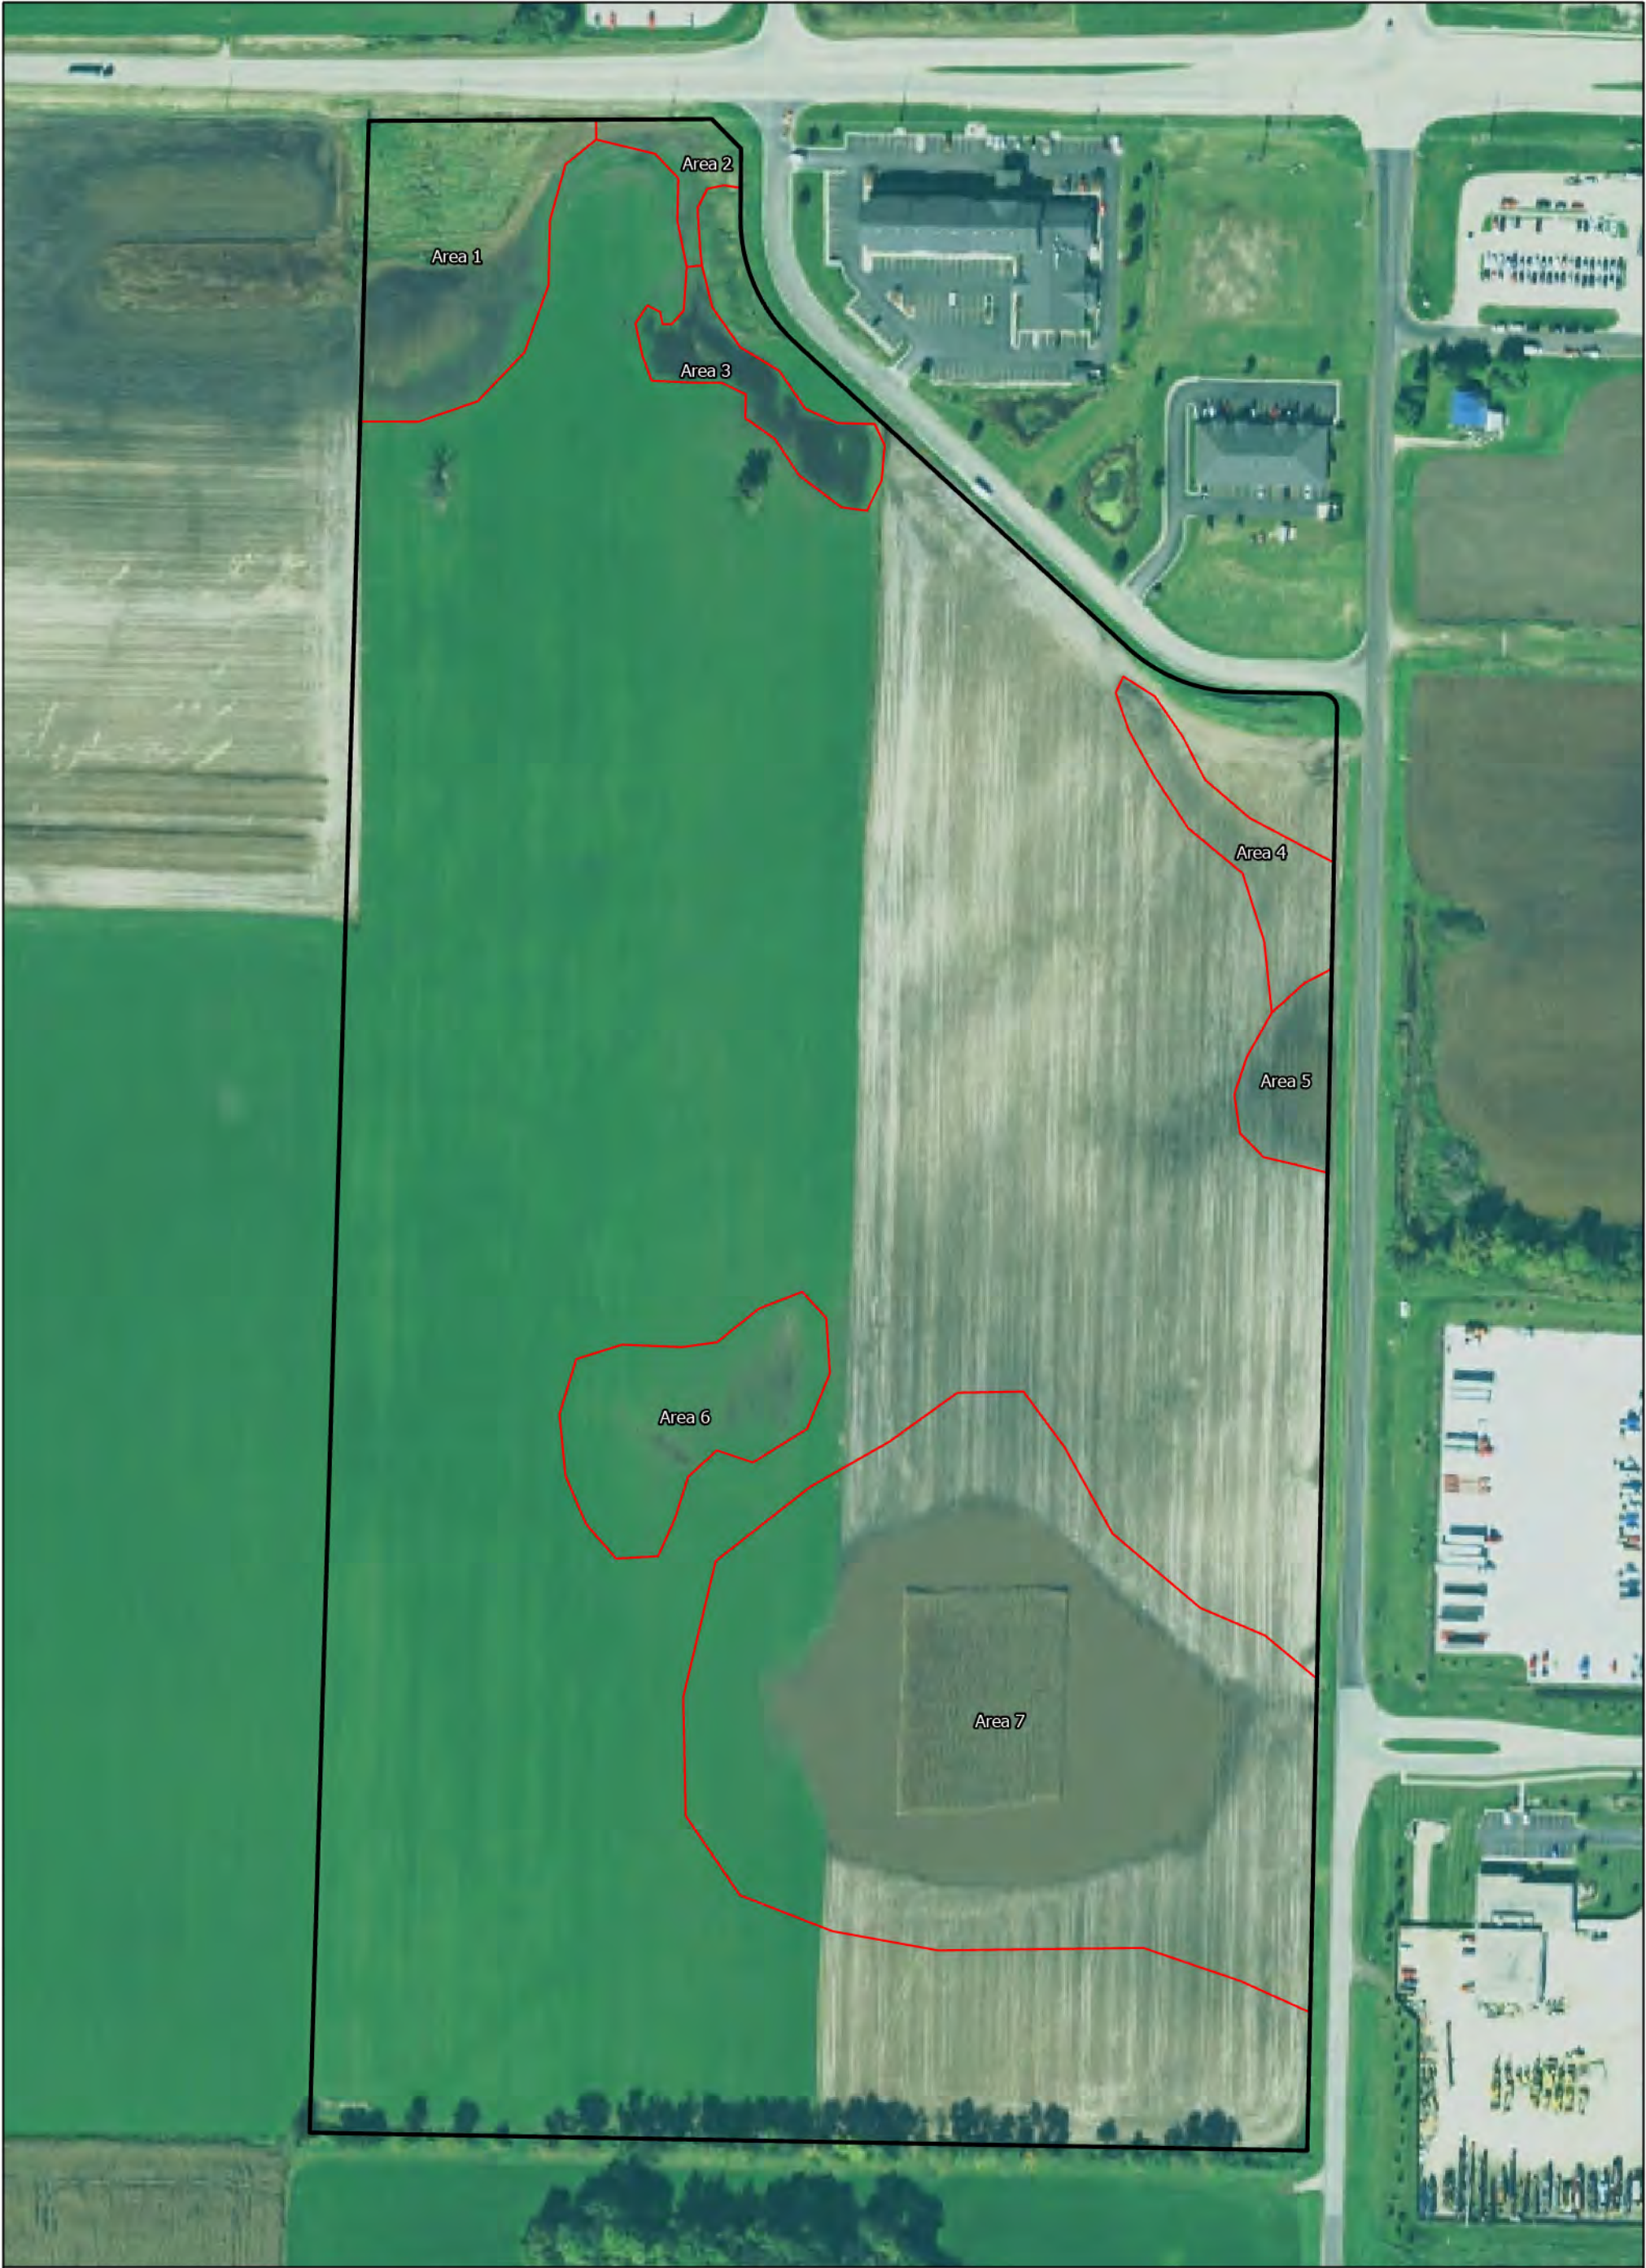
*Wisconsin 7.5 Minute Series (Topographic) Maps*. 1:24,000. Reston, VA.

A total of 21 aerial images were selected and reviewed based on availability and quality of the imagery. Of these images, eight (8) were taken under normal antecedent precipitation conditions. Signatures were noted in seven (7) areas within the Study Area within landscape positions described by the NRCS to support hydric soil components and were the focus of the OSA. At least one (1) of the seven (7) described wetland signatures per the July 2016 Guidance were consistently noted in three (3) of these areas on imagery taken under normal antecedent precipitation conditions.

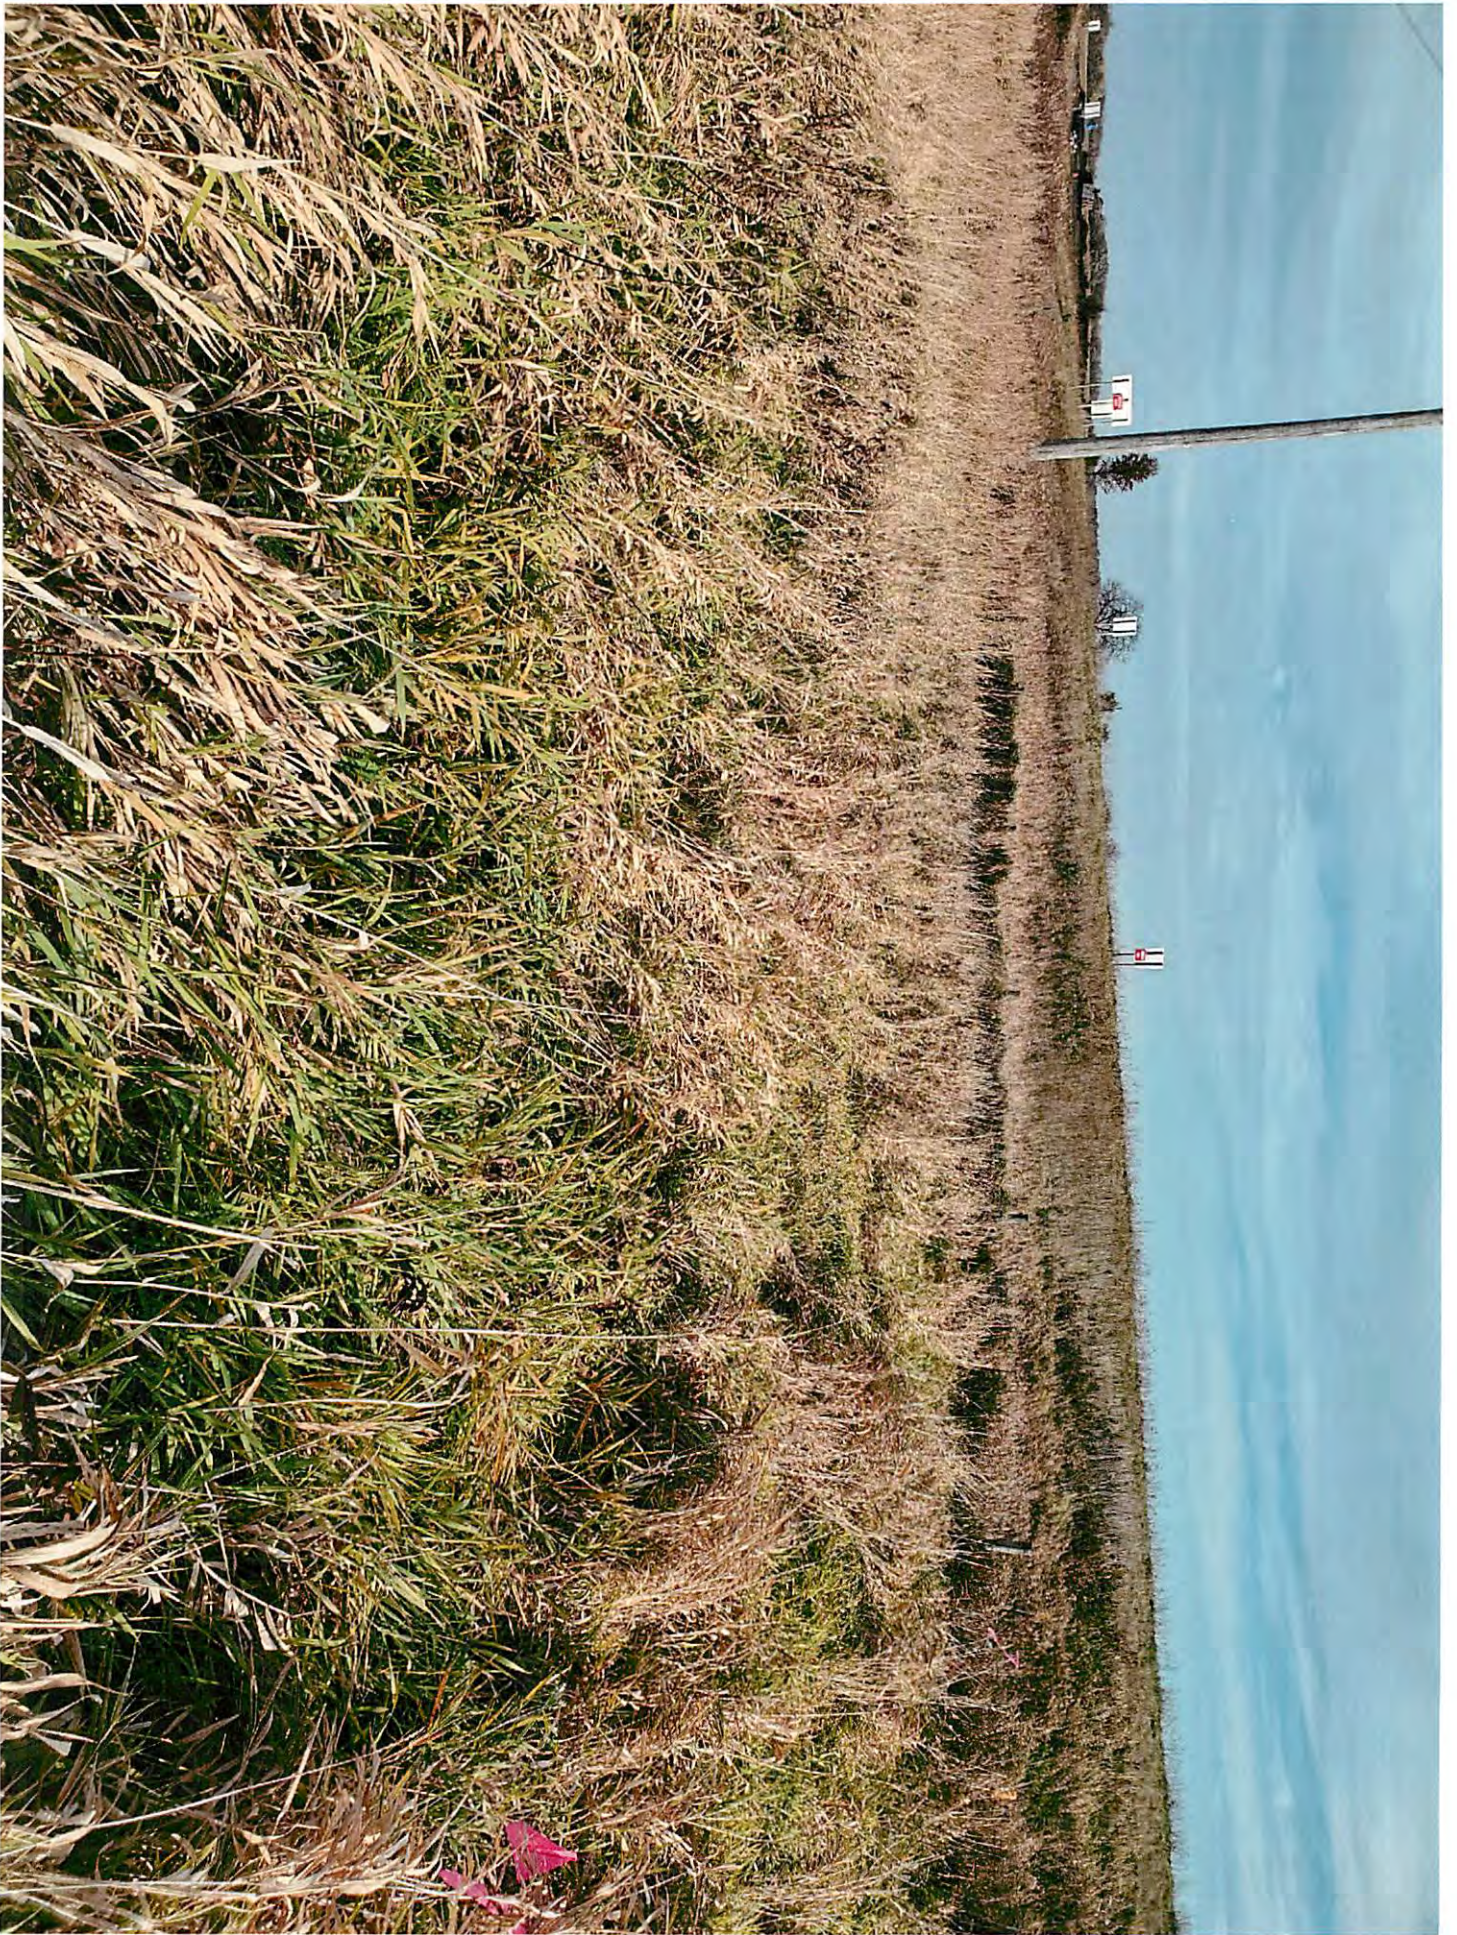
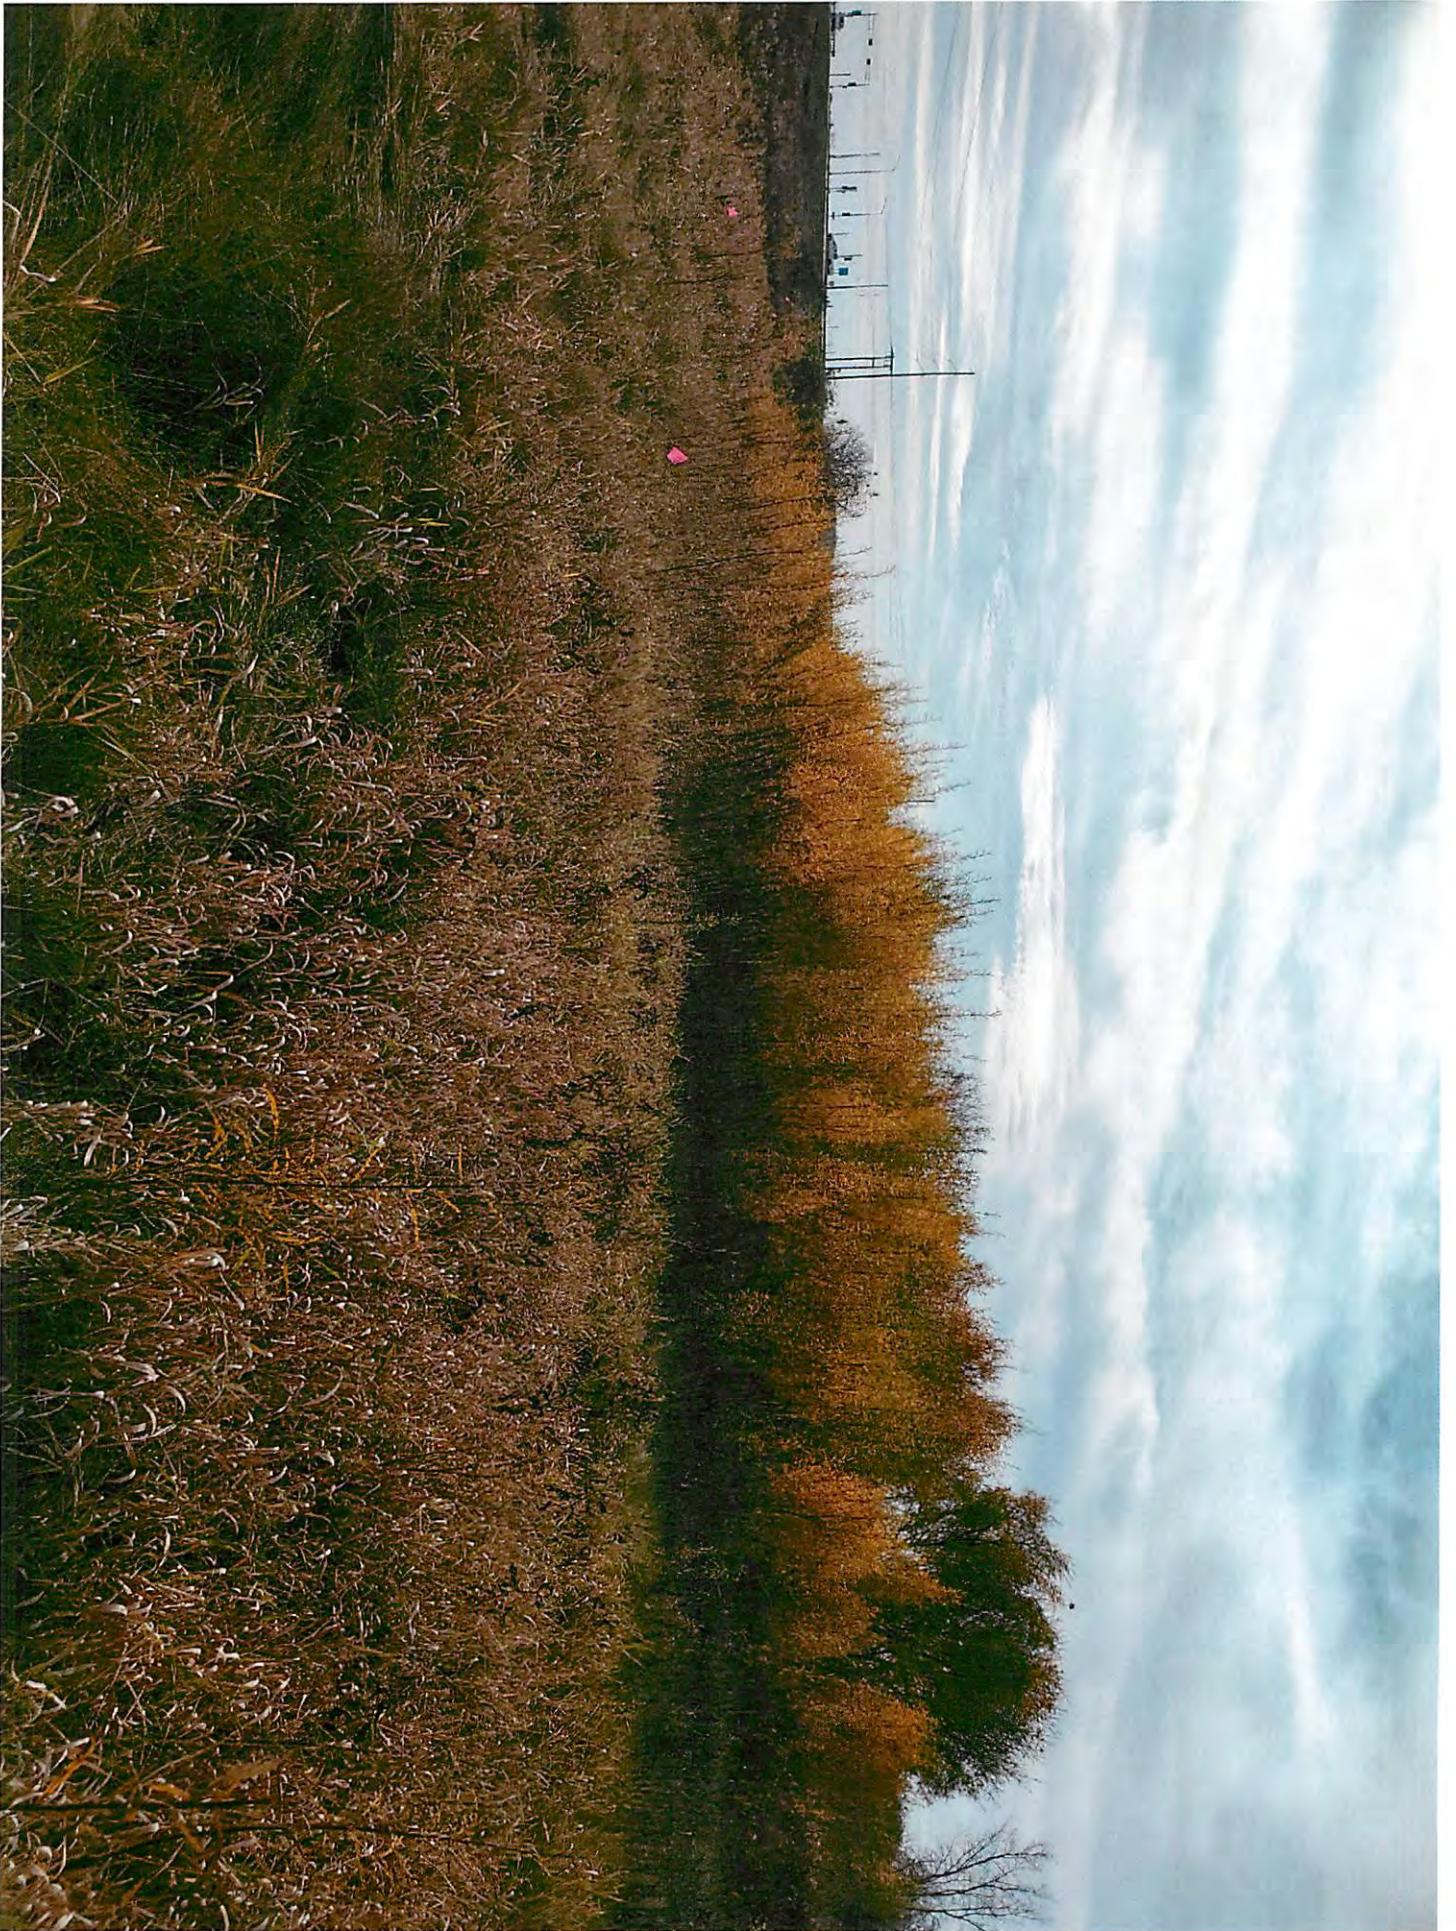
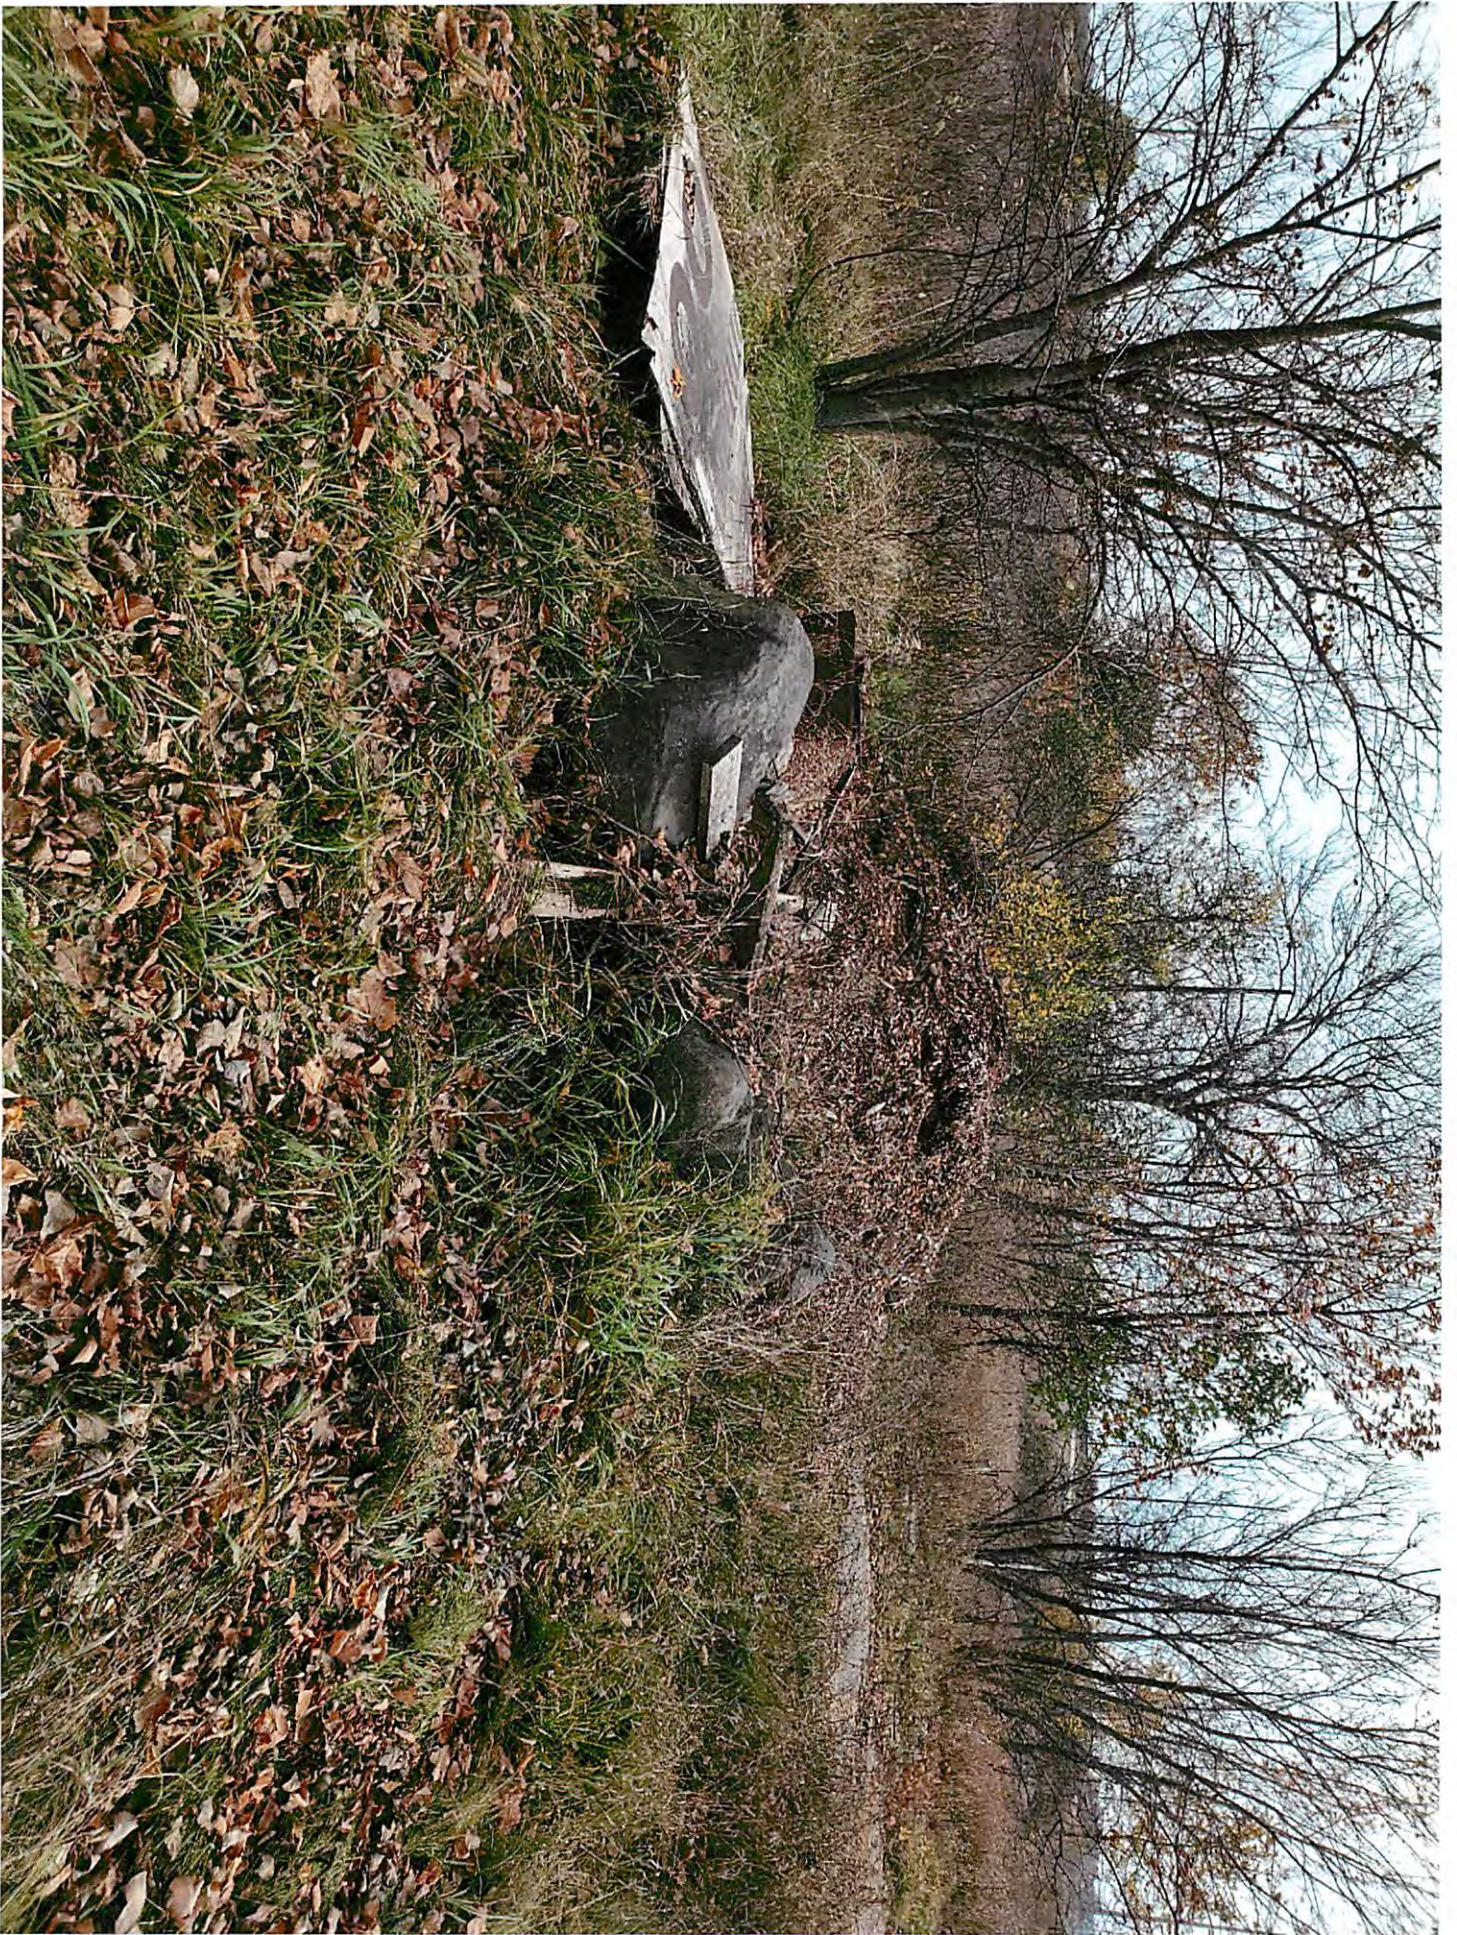
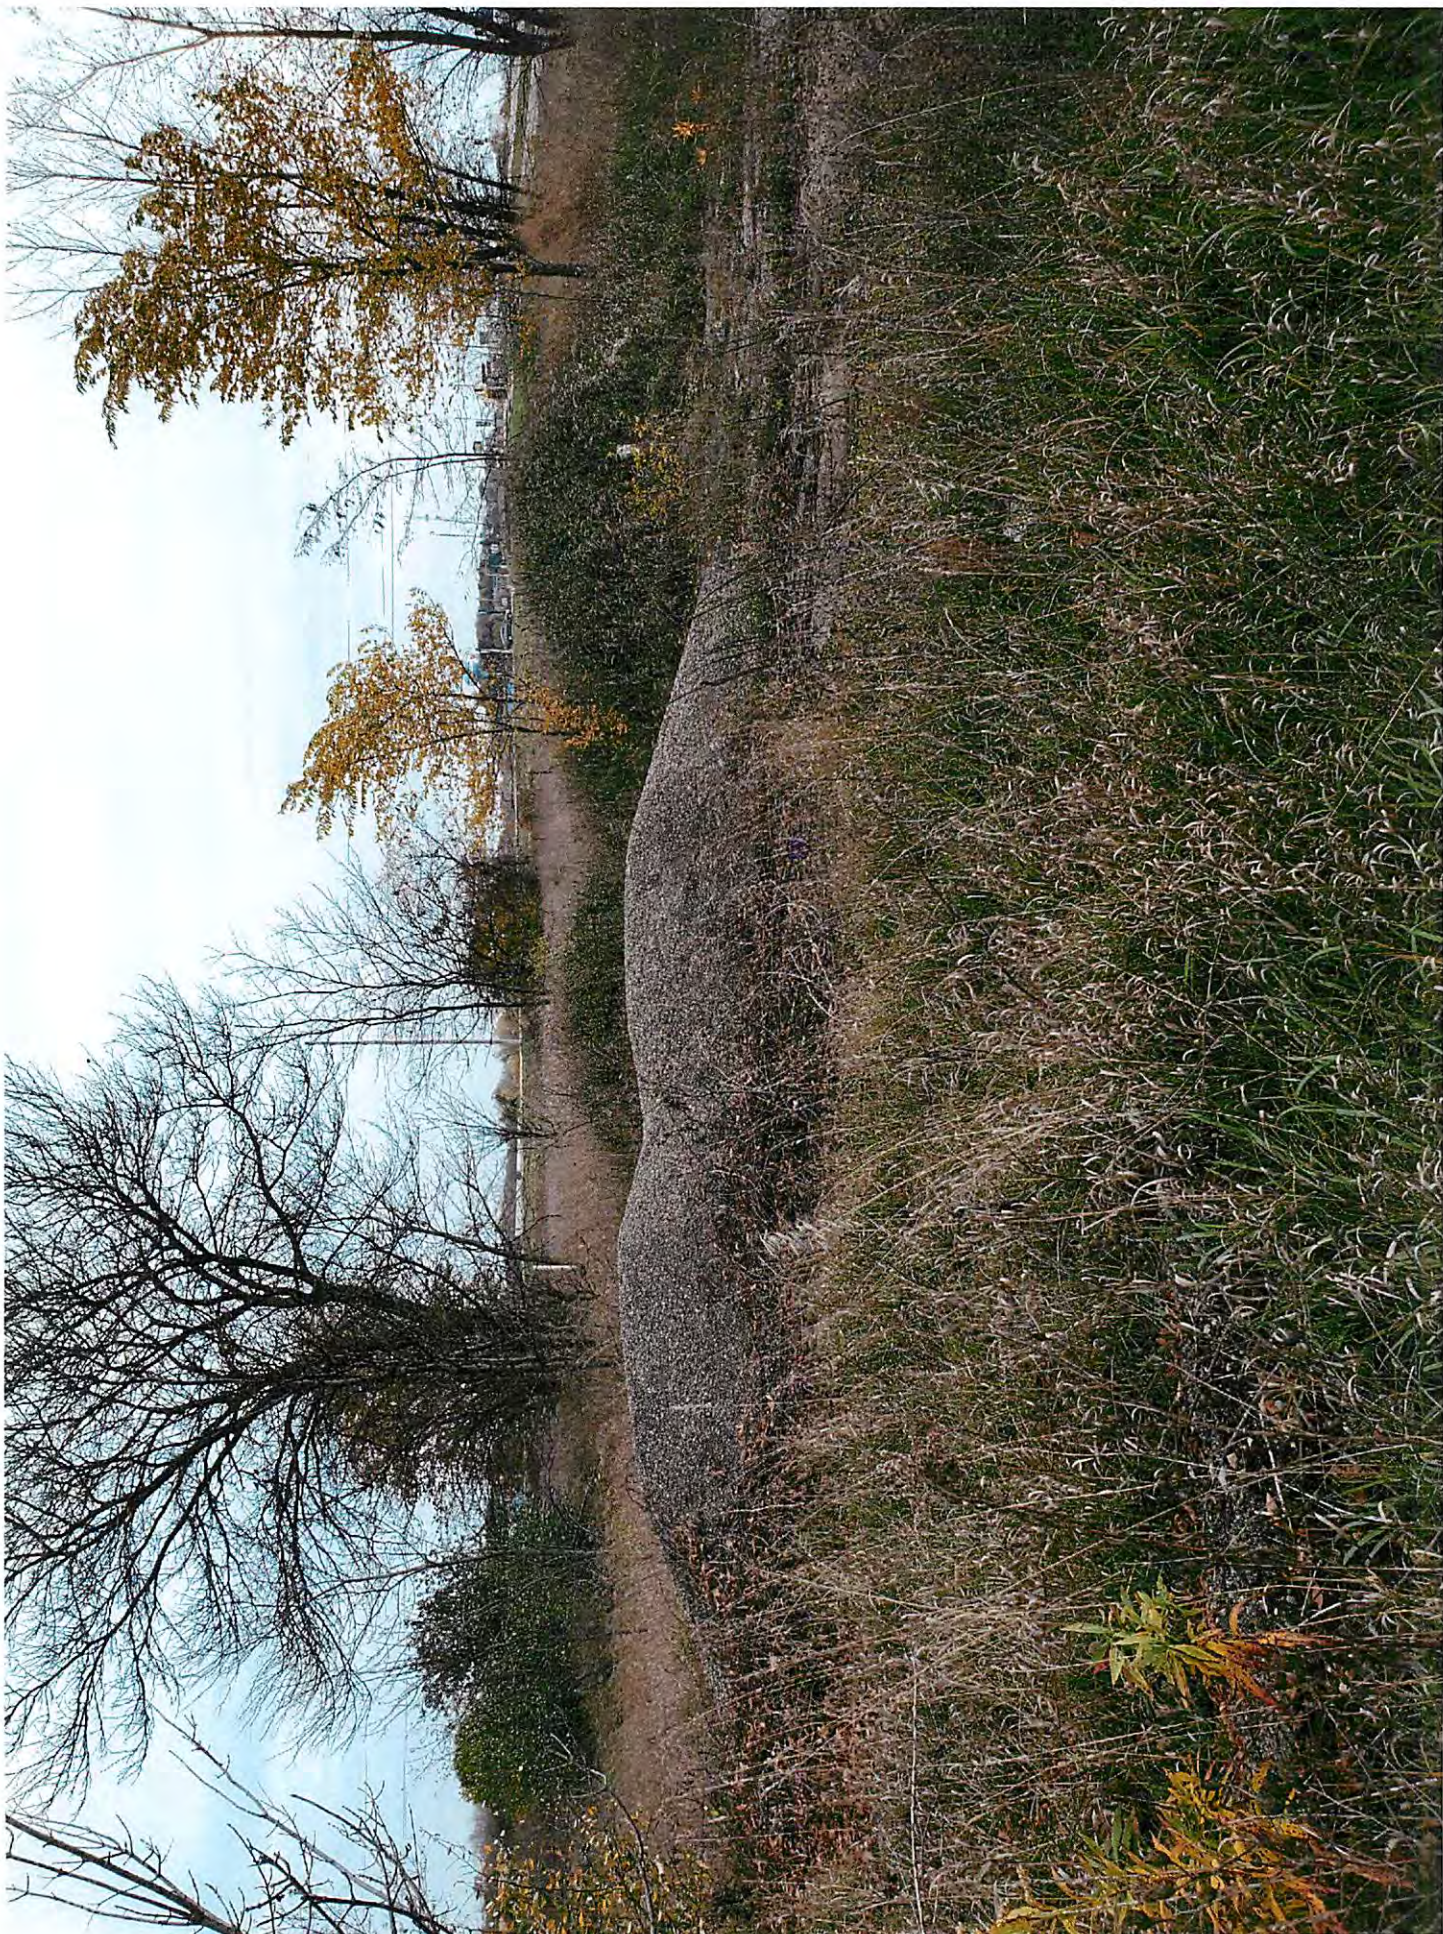
Photos C and D.....Typical views of fill material on the site.
